PAINTINGS EXAMINATION REPORT

CNS 197800

PAINTINGS TREATMENT PROPOSAL

PAINTINGS TREATMENT REPORT

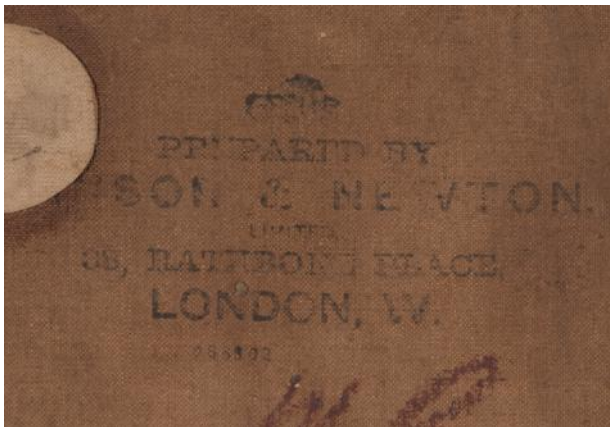
On the reverse, there is a black stamp in the center that states: "[griffin trademark] PREPARED BY WINSOR & NEWTON, LIMITED. 38, RATHBONE PLACE, LONDON, W. 268802" (Fig. 2). This stamp further confirms commercial preparation of this canvas, and indicates the company, the location, and potentially the dating of this canvas' production. According to the National Portrait Gallery London's online survey of Winsor & Newton canvas stamps, this canvas series' production dates were during the 1890s-1910s (Fig. 3), suggesting this work was produced around the 1890s or later (National Portrait Gallery, n.d.). The upper area on the right edge has the inscription "30x25" which appears to be written in graphite. There is also a large inscription that writes: "George Thomson 1672-1734". This inscription is in a dark red color and appears to be applied using paint with wide brush point and scumbled effect. No lining is present. The inscription fluoresces a bright orange under UVA irradiation, indicating that the paint contains a lake pigment.

Figure 2: Canvas stamp.

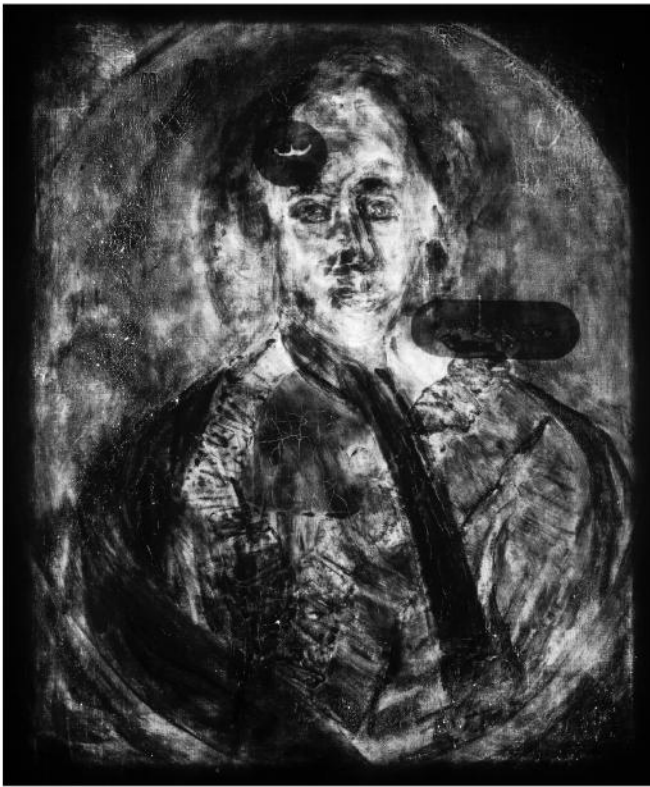
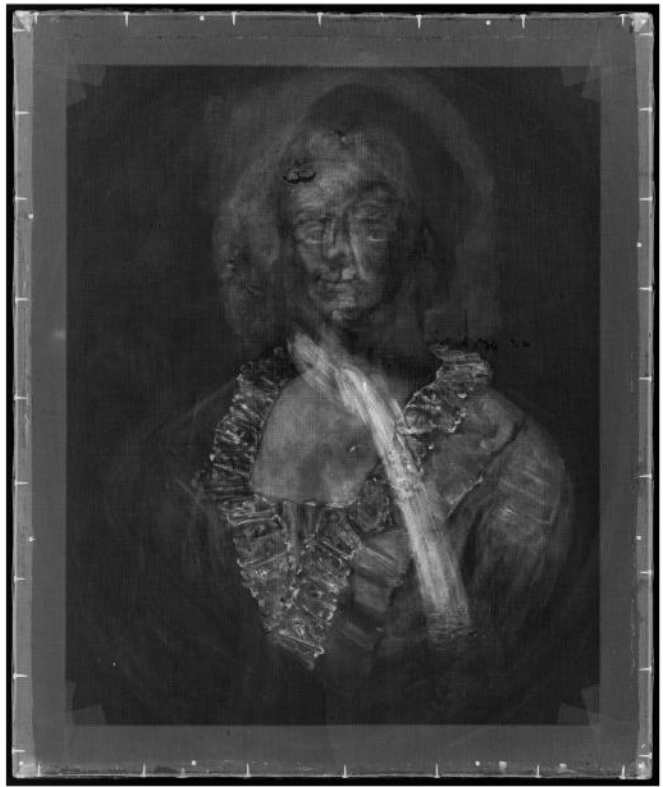
No underdrawing is discernible under normal illumination. Some areas of impasto do not align with the form in the image. Transmitted infrared illumination and X-radiography revealed the presence of a second composition underneath: a portrait of a woman facing the opposite direction in three-quarter view, donning a ruffled neckline making up the bodice of a gown (Fig. 4-5). The earlier portrait appears stylistically similar to the current composition, meaning it may be painted by the same artist. X-ray fluorescence spectroscopy mapping suggested that the former portrait may have been partially or entirely covered up with another lead-based priming layer before painting the present portrait. The composition also appears to have been formerly framed in an oval shape.

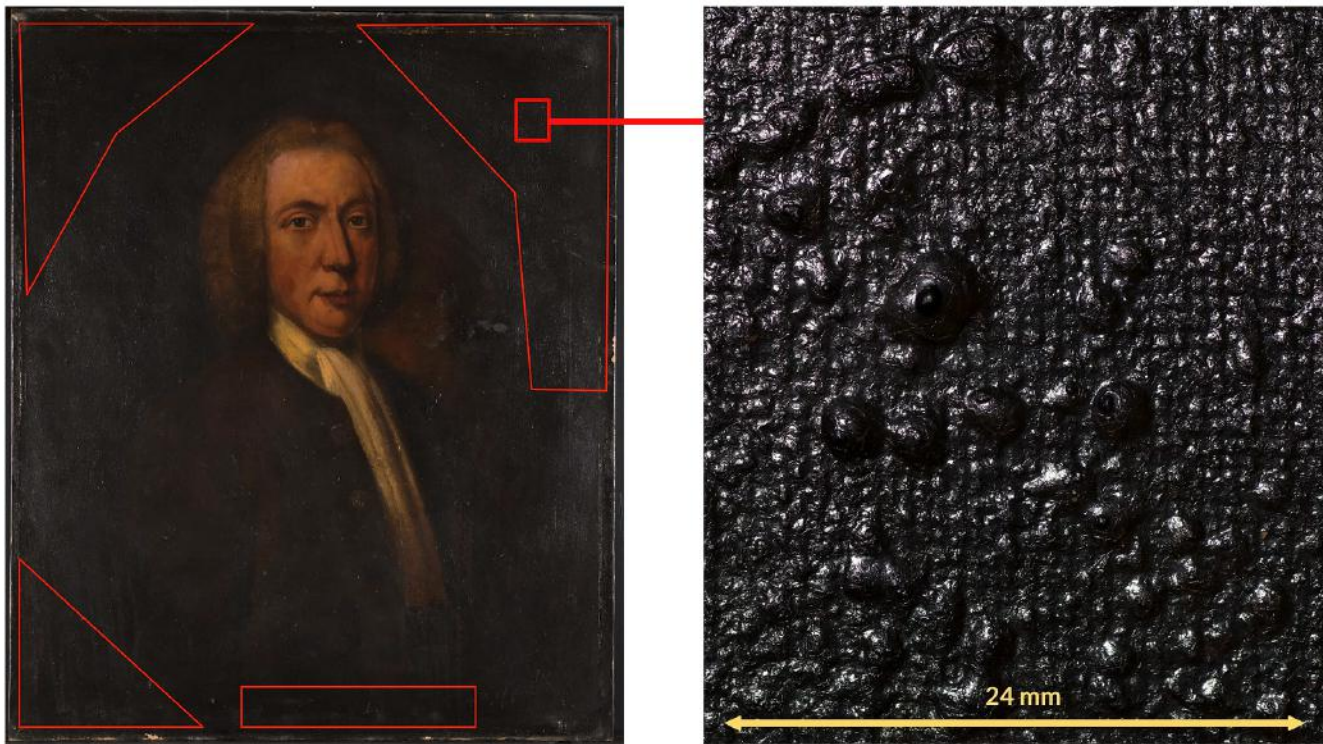
There is blistering throughout the entire surface, likely caused by heat damage, and it is most significant throughout the background and corners of the painting (Fig. 6). There is no blistering in the areas along the edges that were in contact with the frame, which could indicate that the frame protected the paint

Figure 6: Diagram mapping out areas of blistering (left) and photomicrograph detail of paint blistering/bubbling (right).

9. Evaluate possible methods for addressing blistering in the surface.
10. Assess stability of the paint layer around losses and consolidate local areas as needed.

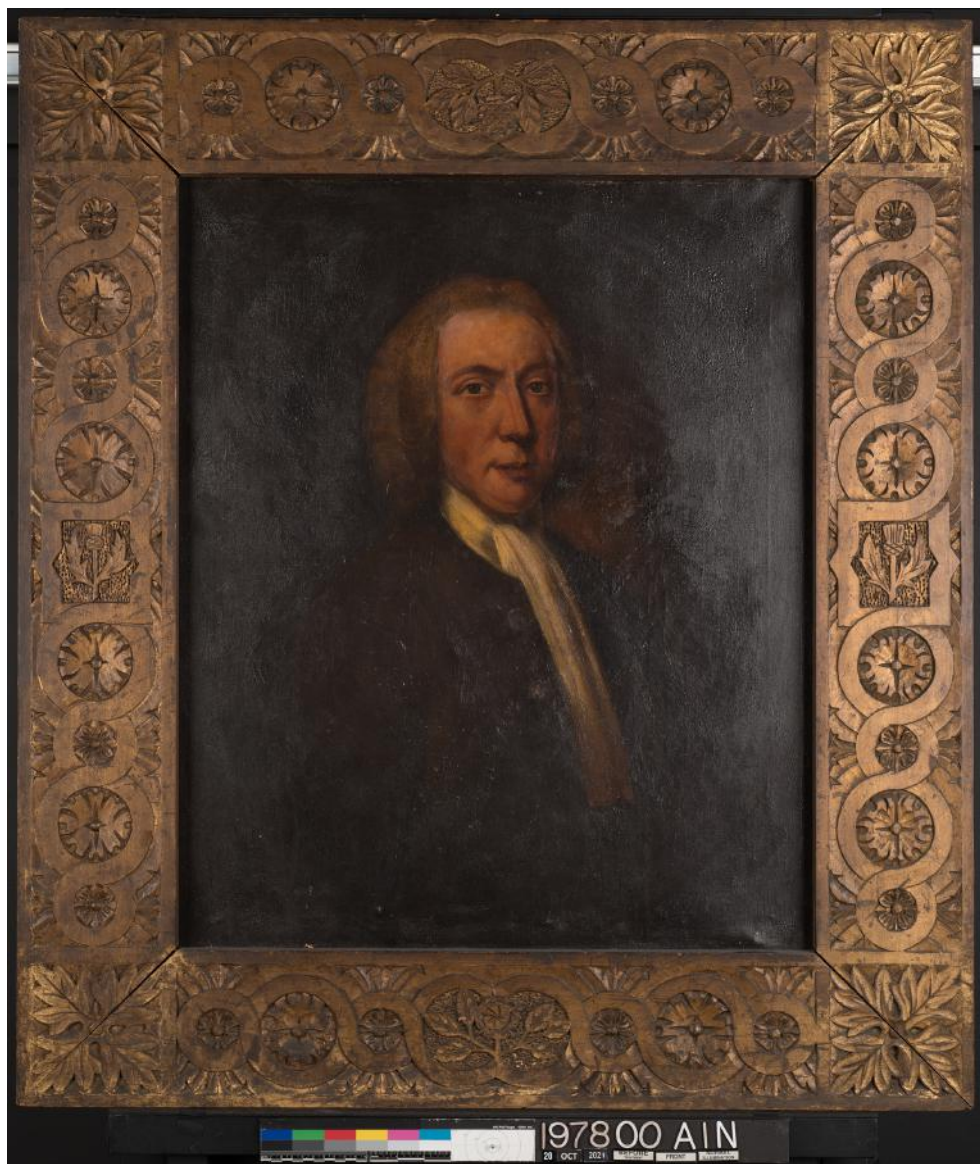
197800_A1N

No.	DESCRIPTION	TECHNICAL NOTES	COMMENTS
A1N	Front, framed, normal illumination, before treatment	Lighting approximates standard viewing conditions.	The painting fits relatively well in its frame. Frame is slightly reflective and has a sheen due to its gold metallic coloring. There is a difference in the sheen between the right and left sides, likely due to various levels of soiling.
A2N	Back, framed, normal illumination, before treatment	Lighting approximates standard viewing conditions.	Hanging hardware in upper half, nails to secure painting into frame.
A3N	Front, normal illumination, before treatment	Lighting approximates standard viewing conditions.	Overall darkening of varnish layer makes it difficult to see the painting composition clearly.
A4N	Back, normal illumination, before treatment	Lighting approximates standard viewing conditions.	Two adhered patches from previous treatment. Large inscription indicating subject of portrait. Stamp denotes commercial canvas production.

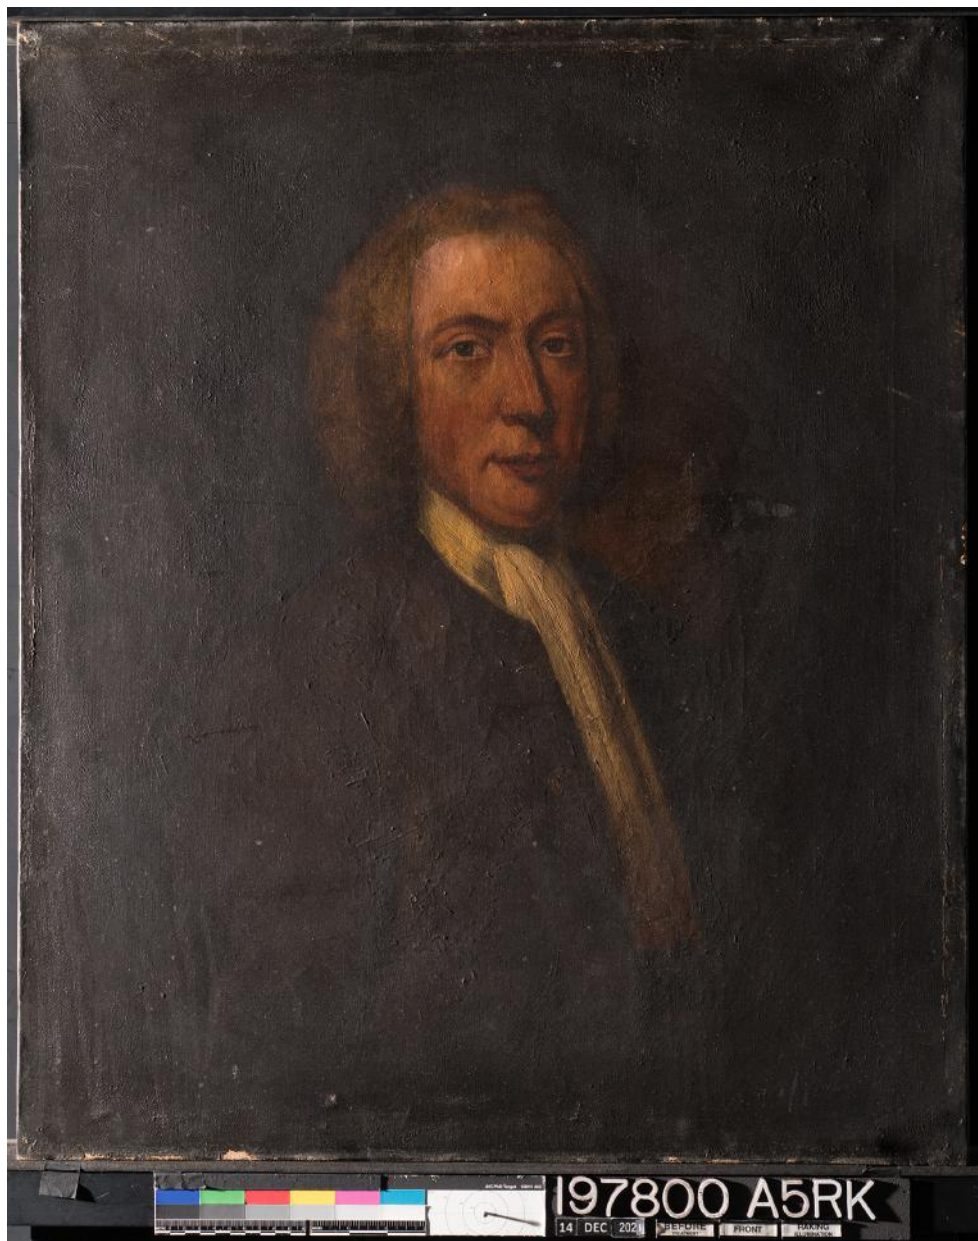
197800_A5RK

A5RK	Front, raking illumination, before treatment	The light was positioned at the left, at a low angle to the surface of the painting in order to emphasize the surface topography.	Note blistering in paint layer, slight draws in corners, small local bulges along the lower edge, hazy drips in lower left quadrant. Impasto is visible.
A6SP	Front, axial specular illumination, before treatment	Lights were positioned adjacent to the camera to create specular reflections on the surface. These reflections provide information about surface characteristics (e.g. matte vs. glossy) as well as information about surface topography (dents, bulges, cracks, etc.)	Very uneven, high gloss and surface sheen due to varnish layer, except in areas of previous cleaning or inpainting. Bulges along lower edge are visible.
A7SP	Front, oblique specular illumination, before treatment	The subject was photographed at an oblique angle opposite the light source. The reflection of the light off the surface provides information about surface characteristics (e.g. matte vs. glossy) as well as information about surface topography (dents, bulges, cracks, etc.)	Area of inpainting or previous cleaning is visible in forehead. Very uneven, high gloss due to varnish layer can be seen. Bulges from possible inclusions are visible along lower edge.

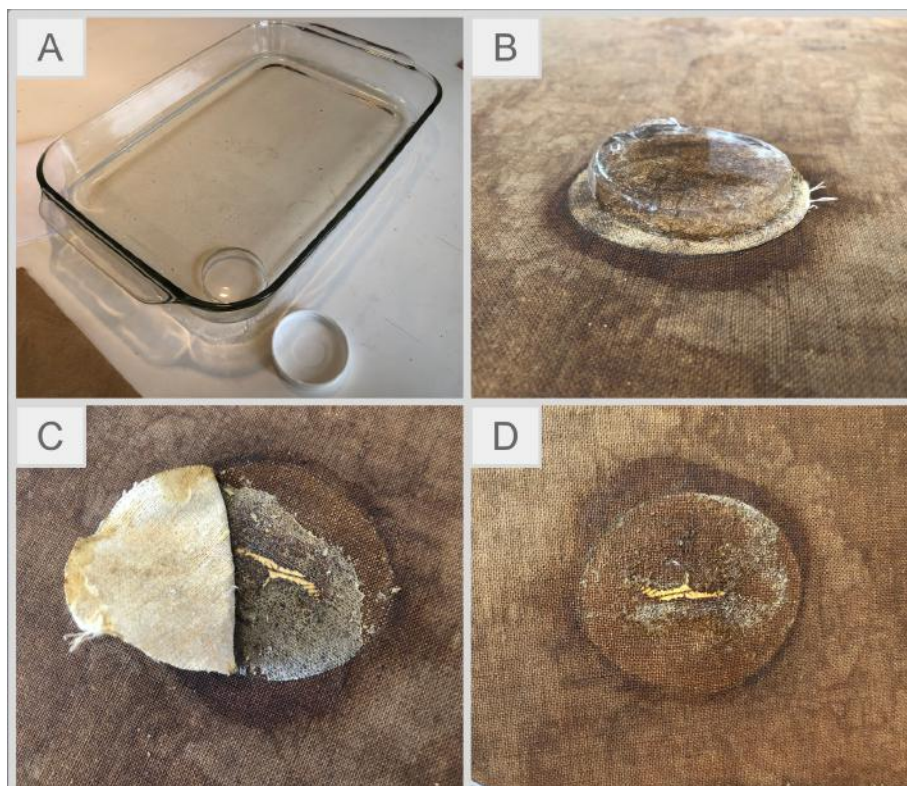
There is a significant layer of dirt, dust, and soiling throughout the reverse. Two canvas patches are adhered to the reverse: one is circular and measures at $2 \frac{3}{4} \times 2 \frac{3}{8}$ inches, and the other resembles a strip with rounded corners and measures at 2×6 inches. The adhesive under both patches is unconfined and leeching out from all edges, and has darkened or discolored to a brown color. Adjacent to the patches are what seems to be two tracings of the same adhesive in the same circle and oval shapes of the patches. It is possible that these impressions were created by the temporary placement of the two adhesive-backed patches on a different area of the canvas. These tracings fluoresce bright, yellow-brown under UVA irradiation. The circular patch has adhesive applied to its reverse as well and has an upward-pointing arrow inscribed on it. The adhesive applied over this circular patch fluoresces dark black under UVA irradiation. The long oval patch is an off-white or cream color and the circular patch may have also been the same color, yet has become discolored due to application of the adhesive.

Figures 2A-D: Process of using gellan gum gel to remove old canvas patch from reverse.

11. Remove patches from reverse of the canvas mechanically or with the use of aqueous methods or solvents as appropriate.
12. Address any additional structural issues present after removing patches.

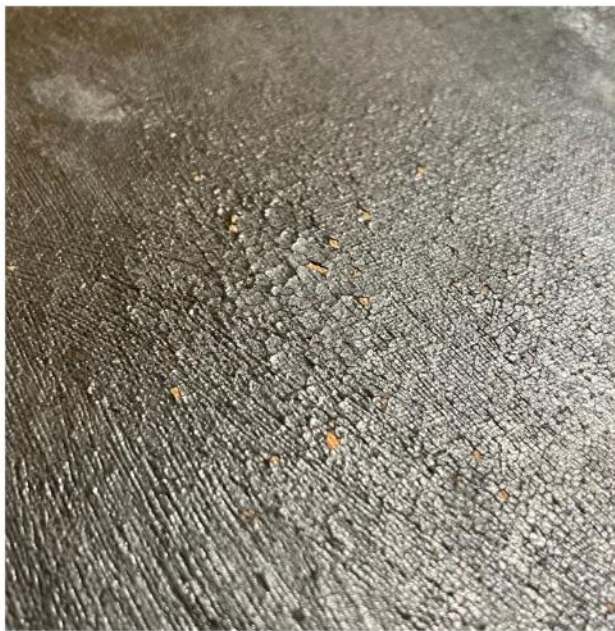
Figure 3: Area of cupping paint before treatment.

8. Conducted solvent solubility testing and repeated as needed throughout different areas of the painting to determine the solubility of the varnish.
9. Reduced varnish in a successive manner using ethanol or a 3:1 mixture of ethanol to Odorless Mineral Spirits⁵ depending on the area and its solvent sensitivity.
10. Reduced overpaint using ethanol and custom-rolled cotton swabs, while examining under the microscope as necessary.
11. Consolidated additional area of flaking and cupping paint using dilute BEVA 371⁶ in 1:1 xylene and naphtha. Gently set down paint layers using a heated tacking iron, applying heat through silicone release Mylar⁷ (Fig. 3-4).

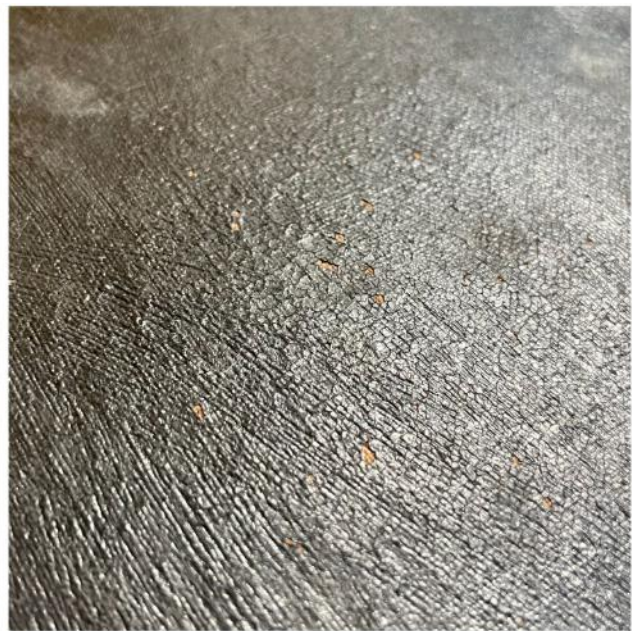
Figure 4: Area of cupping paint after treatment.

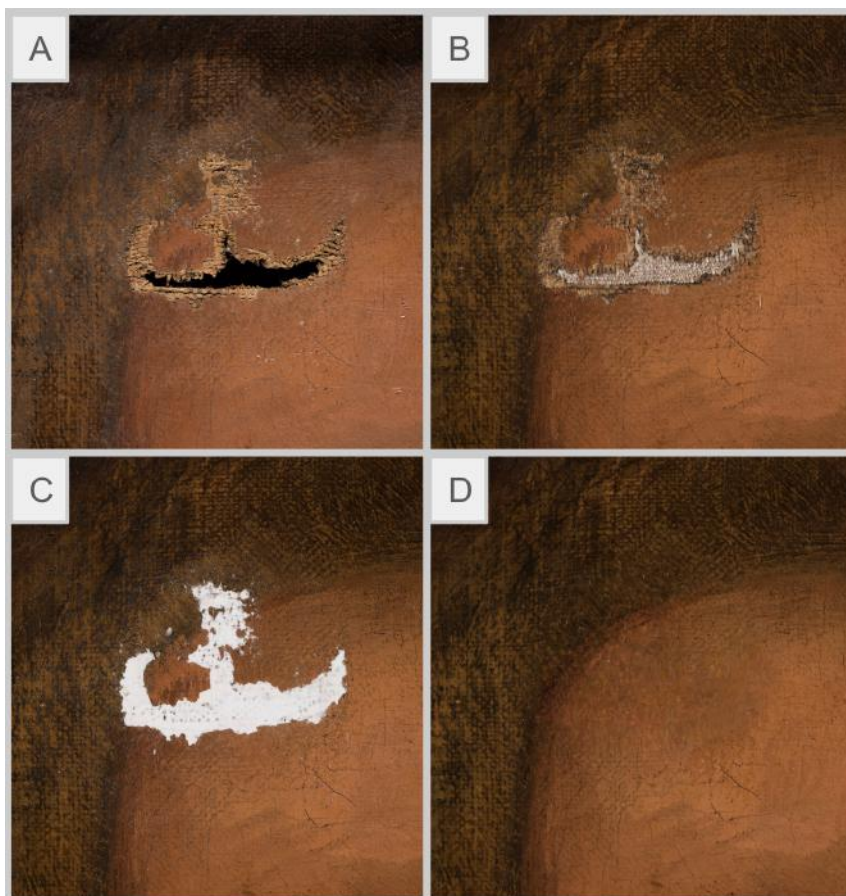
Figure 6: A) Loss in forehead before tear repair, B) After tear repair, C) After filling, D) After inpainting and varnishing.

12. Repaired the tear and structural loss in forehead area with a canvas insert. Selected a linen canvas with similar weight and weave structure. Traced area of loss with Mylar polyester film⁸ and a Sharpie pen. Used Mylar tracing to cut canvas insert to shape. Adhered canvas insert into area of loss using an adhesive mixture of 20% isinglass and 10% wheat starch paste in a 1:1 ratio in deionized water, then left area under weight overnight. Several dots of Lascaux polyamide welding power⁹ were applied afterward along the join areas of the insert. A heated wax-carving tool with interchangeable tips was used to apply and cure both adhesives. The area was then locally humidified with dampened blotter and flattened under weight.

16. Inpainted fills using Galdehyde¹⁶ resin mixed with stable dry pigments and a diluent of 1-methoxy-2-propanol (Fig. 6).
17. Applied a final varnish of 18.5% Laropal A81¹⁷ in 3:3:4 Shellsol A100 to Shellsol 340 to xylene with 2% Tinuvin 292 by spray gun.
18. Attached a custom rigid backing board made of single-walled corrugated board¹⁸, Fome-cor¹⁹, and mat board²⁰.
19. Dusted frame and removed old hanging wire and hardware.

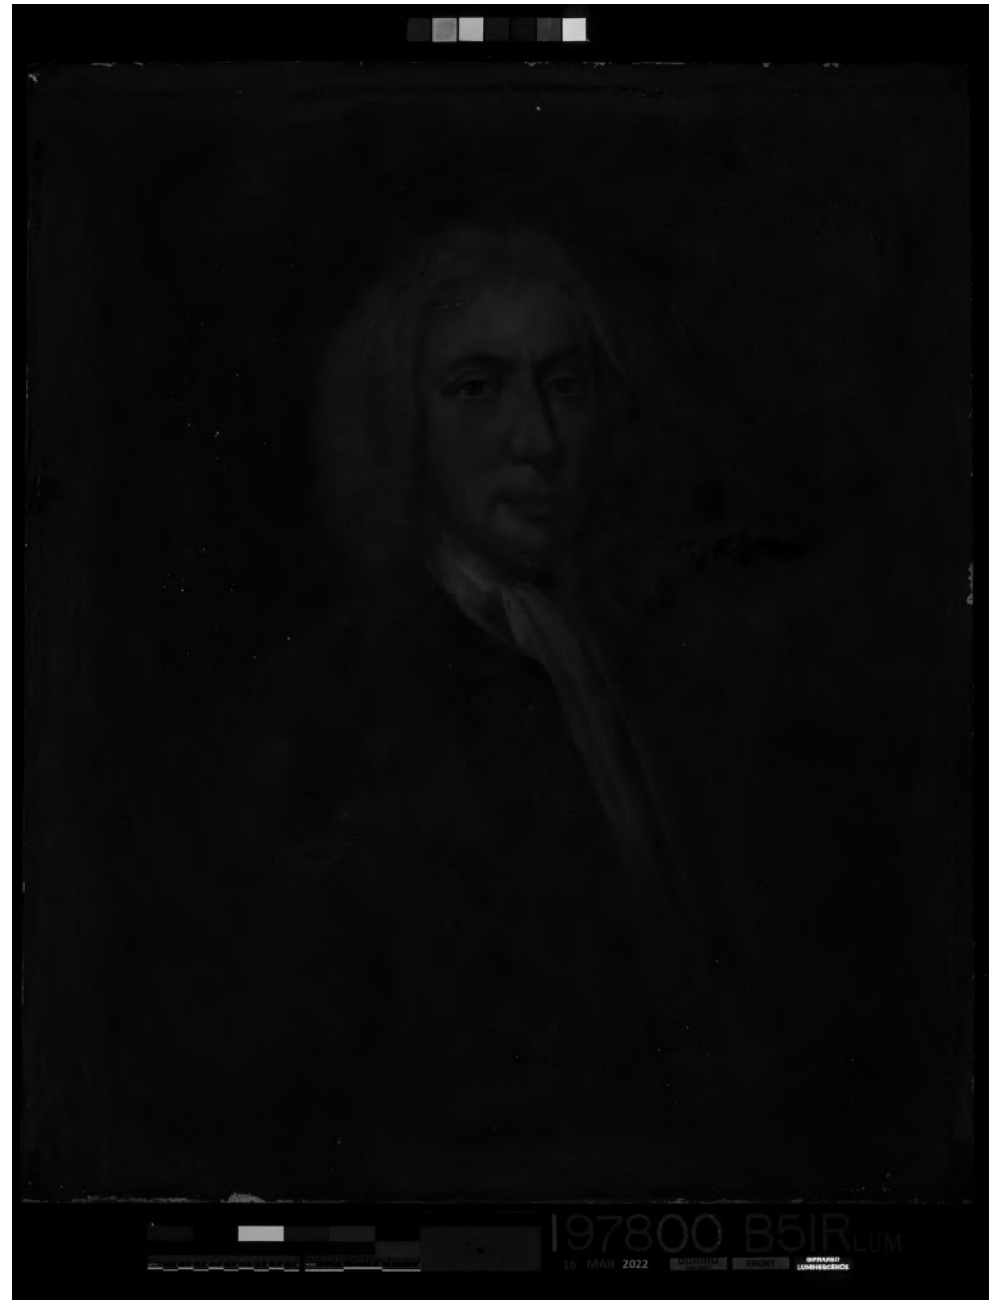
197800_B5IRLUM

B5IRLUM	Front, infrared luminescence, during treatment	<p>The subject was illuminated with an infrared free visible light source. The visible light energy is absorbed by some materials in the subject and released as invisible near infrared luminescence. The luminescence is photographed using a special camera filtered to record only infrared radiation.</p> <p><i>Illumination source and filtration: White Light LED covered with BG38 filter</i> <i>Camera filtration: Kodak Wratten 88A</i></p>	No bright luminescence observed and did not reveal additional information about the painting.
B6FCUV	Front, false color reflected UVA, during treatment	<p>The subject was placed in front of a long wave ultraviolet lamp (blacklight). A camera with sensitivity to the invisible ultraviolet radiation was used to record how the ultraviolet was absorbed (area appears dark) or reflected (area appears light) by materials in the subject. This image can aid in differentiation or characterization of materials. Because the ultraviolet penetrates little beyond the surface, the visibility of anomalies in surface can also be enhanced.</p> <p><i>Camera filtration: X-Nite CCI+B+W403</i></p>	Did not reveal additional information about the painting.

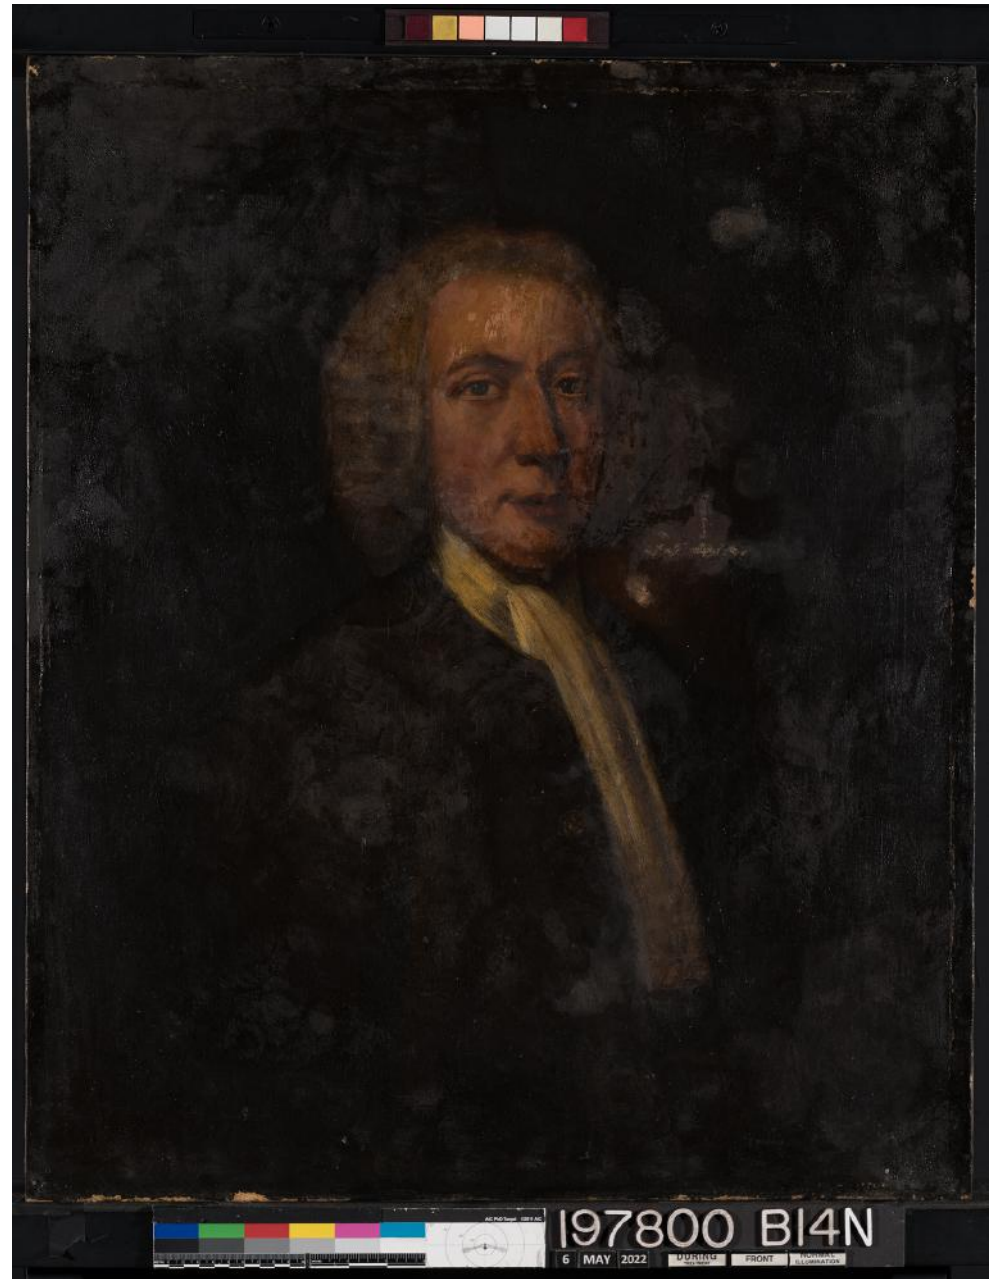
197800_B14N

B14N	Front, normal illumination, during treatment	Lighting approximates standard viewing conditions. <i>Camera filtration: X-Nite CCI</i>	Surface sheen is altered due to in progress varnish removal. In progress areas of overpaint removal are visible in the background adjacent to the right of the sitter's face, where fill material can be seen. Some blanching is present.
B15UVA	Front, UVA-induced visible fluorescence, during treatment	Irradiation setup approximates standard viewing conditions under UVA-vis fluorescence using a stabilized radiation source. The subject was photographed in a darkened room while irradiated by a long wave ultraviolet lamp (blacklight). The ultraviolet radiation causes some materials in the subject to fluoresce (emit light). <i>Camera filtration: X-Nite CCI+PECA 9I8+2E #2</i>	Reveals progress of varnish removal/reduction so far.
B16SWIR_composite	Front, reflected shortwave infrared (infrared reflectogram), during treatment	The subject was illuminated with incandescent lamps. An imaging camera, sensitive to the invisible shortwave infrared radiation emitted by the bulb was used to record how the radiation penetrated the subject, or was absorbed or reflected by the materials in the subject. Infrared radiation may penetrate overlying layers to reveal underlying information or may help to characterize materials or to distinguish different materials that are similar in appearance. <i>Imaging camera sensor: InSb Filtration (wavelength band): C, 1530-1700 nm Mosaic tile field of view: full painting</i>	Reveals evidence of a prior composition and some reworking below the current image. There is a black mass behind the current figure's head, which appears to be the form of a prior sitter's head and hair. There are bold strokes outlining the form of a figure's neck, shoulders, and arm. The composition formerly had oval-shaped framing.
