CONSERVATION EXAMINATION REPORT

Title: Adoration of the Golden Calf

Conservator: Josephine Ren (graduate intern)

CONSERVATION TREATMENT REPORT

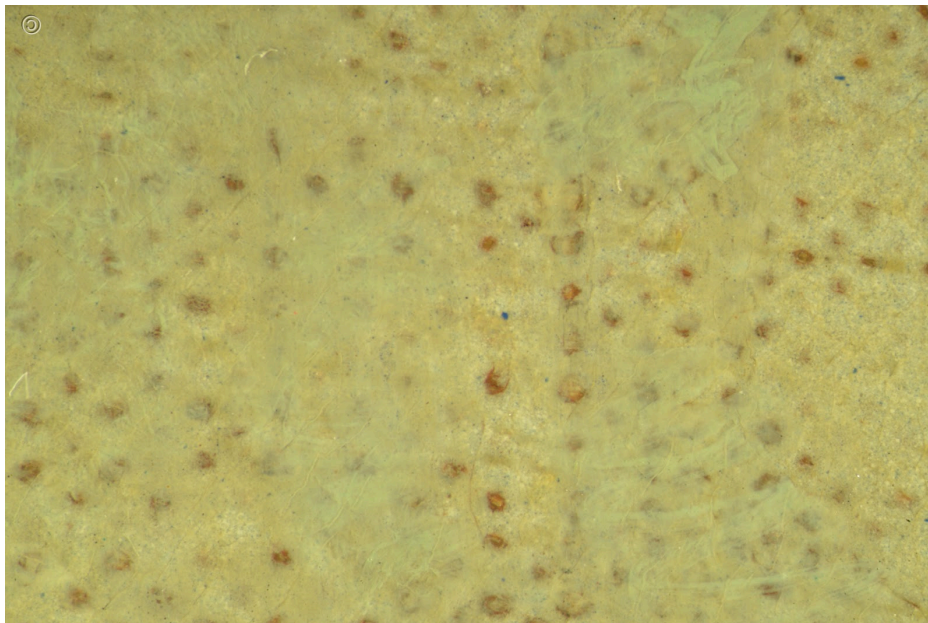
Micrograph detail before treatment, showing overpaint in blue sky area.

9. Reduced overpaint in select areas using a tailored cleaning system. Areas were selected based on whether the original paint was stable and where the overpaint was covering, altering, and/or distorting the original composition. Prepared an emulsion consisting of around 2% xanthan gum thickener, 0.5% EDTA chelating agent, 15% benzyl alcohol, and water adjusted to a pH of 9. Applied emulsion to areas of overpaint and agitated with a brush. Mechanically reduced the softened overpaint using surgical and micro-surgical scalpels with the emulsion present. Removed emulsion and overpaint with a dry brush or swab, cleared area with water adjusted to pH of 8.5, then cleared area with odorless mineral spirits. In some areas, old waxy fill material was also present and had to be removed using the xanthan gum emulsion and mechanical action. Other areas of thinner overpaint, retouching glazes, and remaining coating residues were cleaned using acetone and cotton swabs. All work was completed under the microscope.

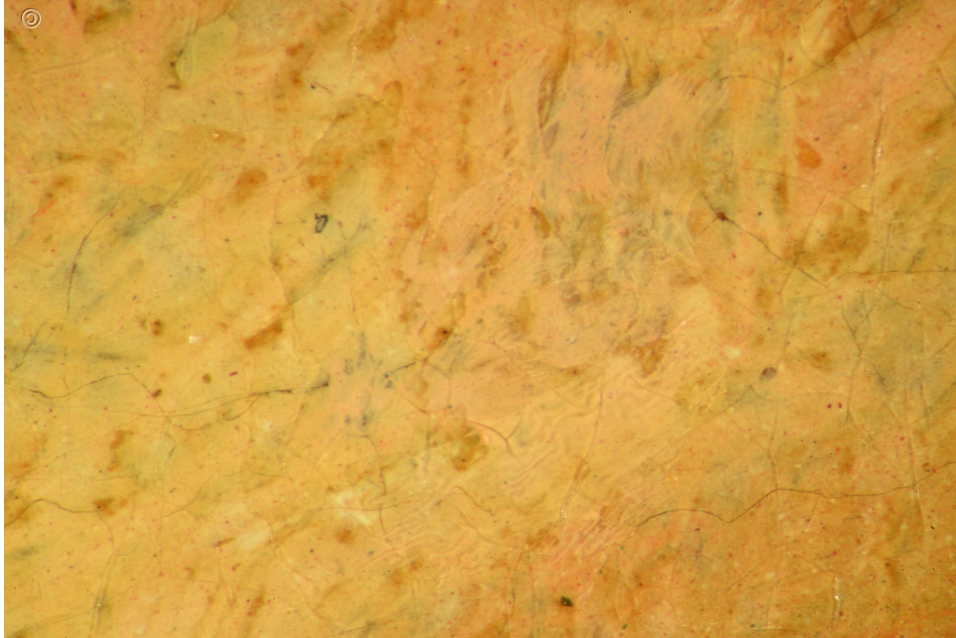
Micrograph detail before treatment, showing overpaint in lower left female figure's face

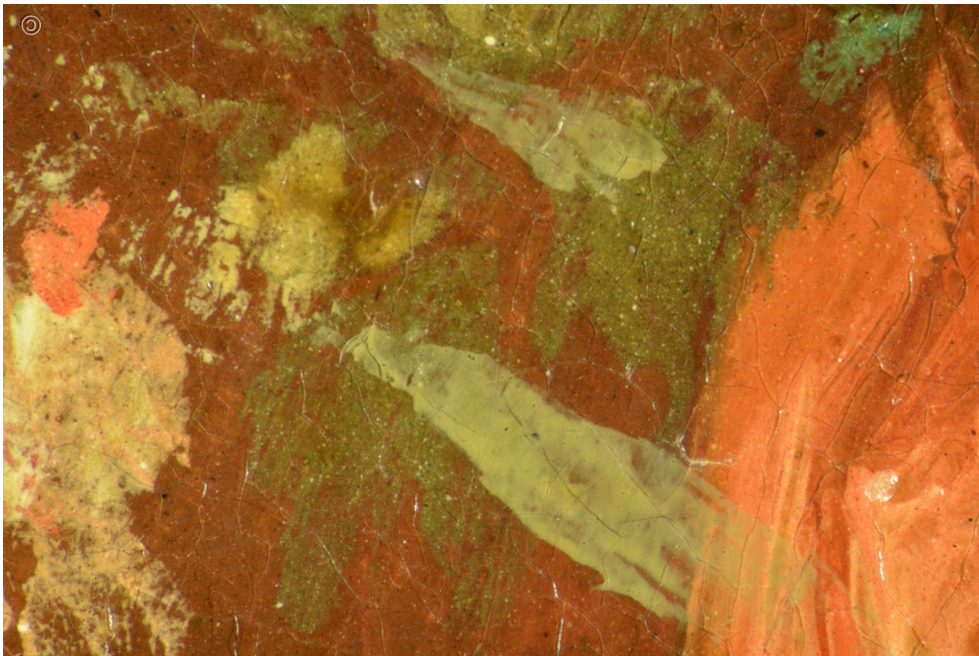
Micrograph detail before treatment, showing overpaint in flower crown of leftmost male figure.

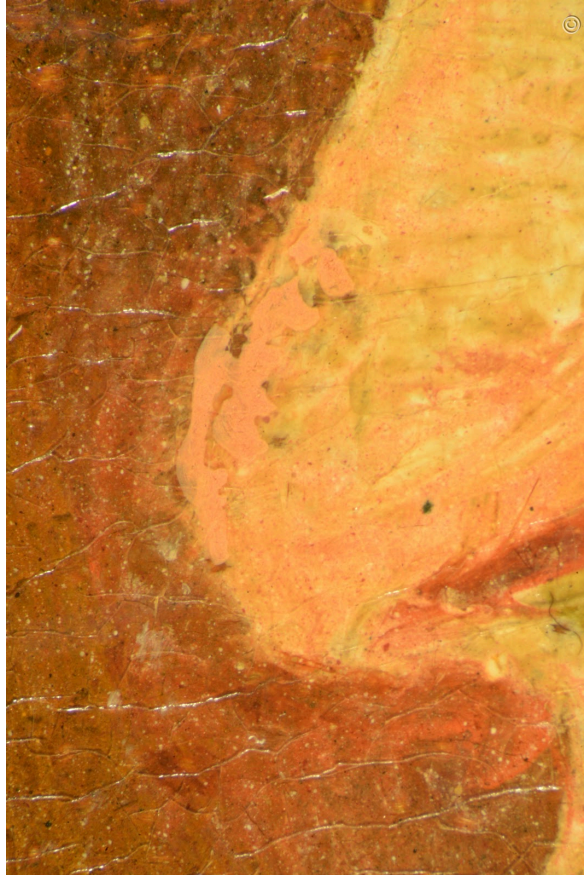
Micrograph detail before treatment, showing overpaint in nose of rightmost male figure.

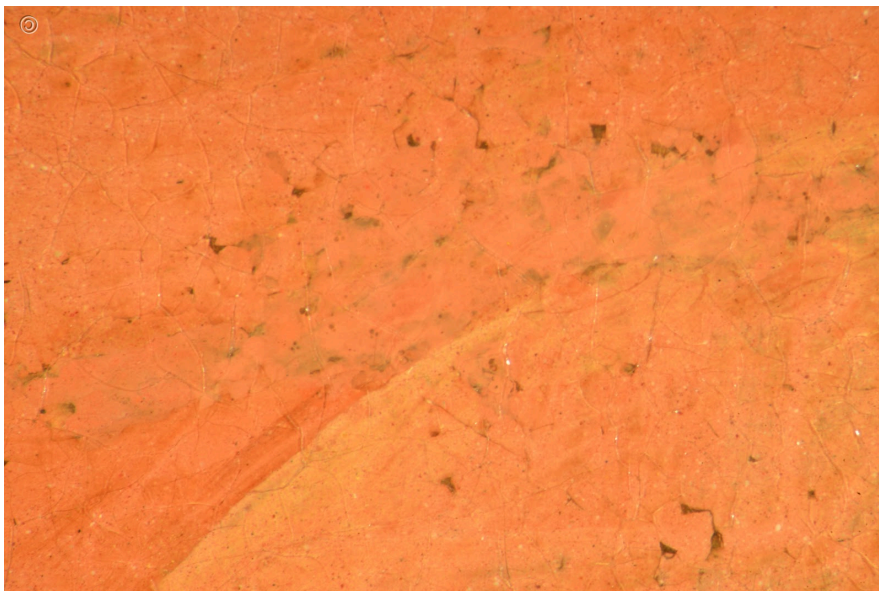
Micrograph detail before treatment, showing overpaint in pink robe of left male figure.

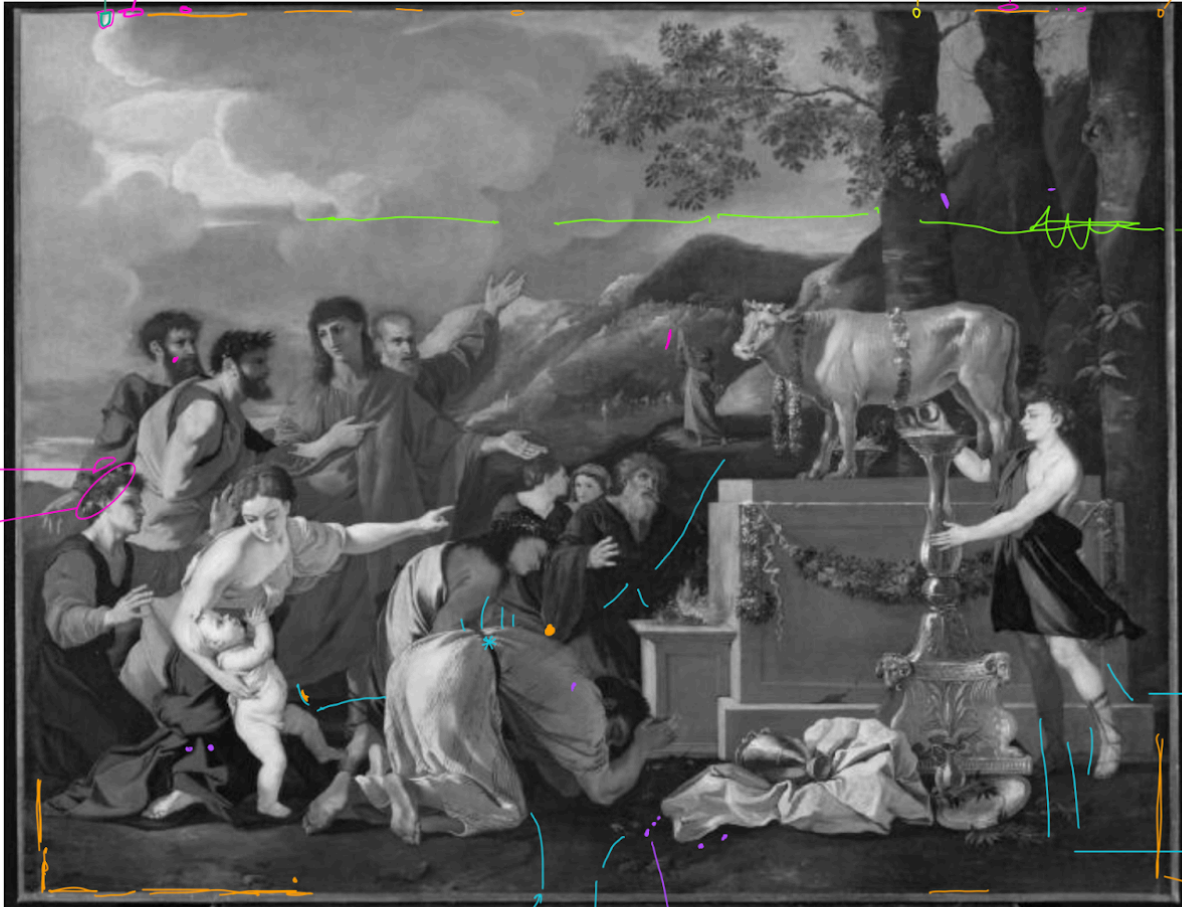
Condition diagram.

blue paint → original?
paint loss? retouch? white
underneath

Disturbance in varnish/possible pressure against paint → frame?

paint loss/loose flake

white underneath → fill?
ground? but overall
ground is red

gold flecks - from frame?

paint loss

inpainting? over loss (no fill?)

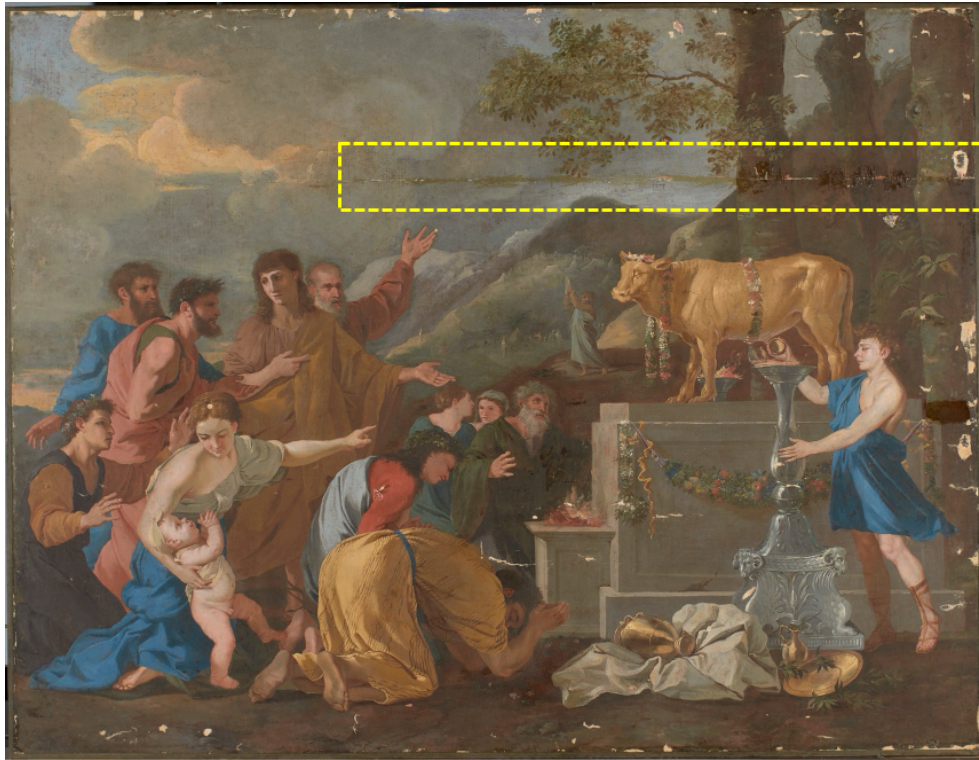
After varnish removal. Annotated area of restoration adhesive material along tear, before its removal.

7. Removed thick restoration adhesive material that was present along the length of the horizontal tear on the painting's face. Softened adhesive with deionized water as needed and removed bulk of material with flat-tipped scraper tool and tweezers. Cleaned remaining residues of material and overpaint with acetone and cotton swabs. All work was completed under the stereomicroscope.

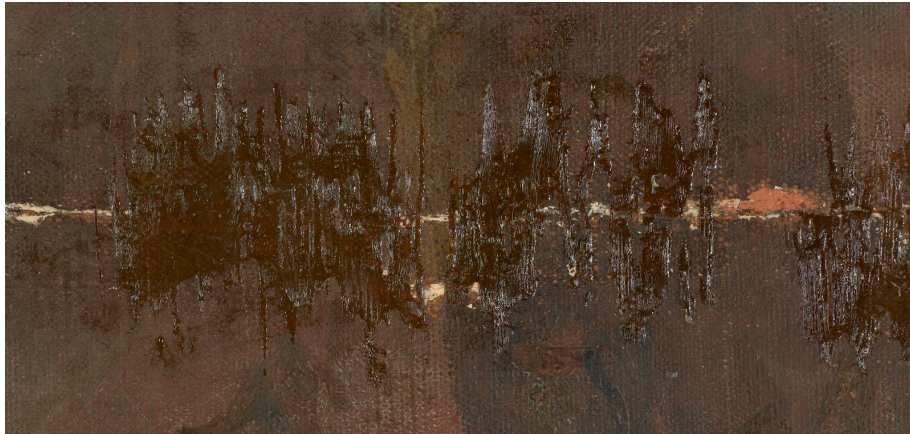
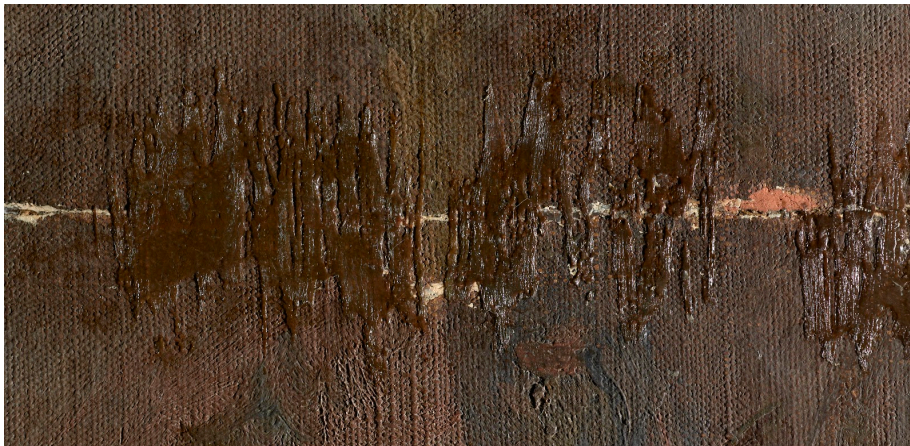
Details of area with restoration adhesive material. Specular light (top) and raking light (bottom).

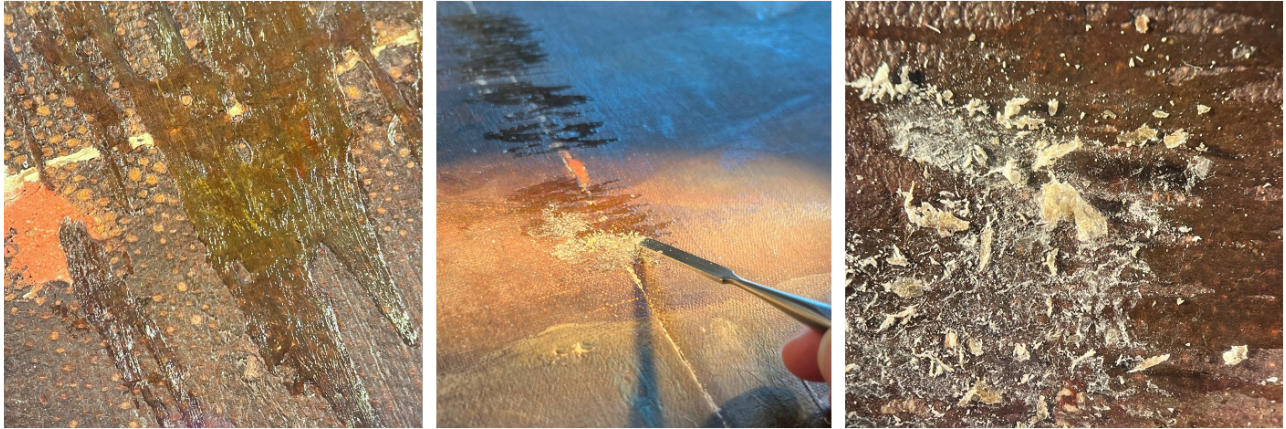
Removal of composite restoration adhesive material that was on paint surface along the horizontal tear.
Left to right: micrograph of restoration material, mechanical removal of material, detail during removal.

Restoration adhesive material was revealed along the length of the tear on the face of the painting. Samples of the material were collected and sent to the Buffalo State Garman Art Conservation Department, where conservation science professor Dr. Rebecca Ploeger performed FTIR analysis to identify the adhesive material. Dr. Ploeger's analysis revealed that the samples contained poly(vinyl acetate) or poly(ethylene vinyl acetate), poly(vinyl alcohol), natural wax, and natural resin. This composite restoration material was removed by softening the material with deionized water, mechanically removing the bulk of it with a flat-tipped scraper tool and tweezers, and then cleaning remaining amounts of adhesive and overpaint with acetone and cotton swabs. This process was done under the microscope.

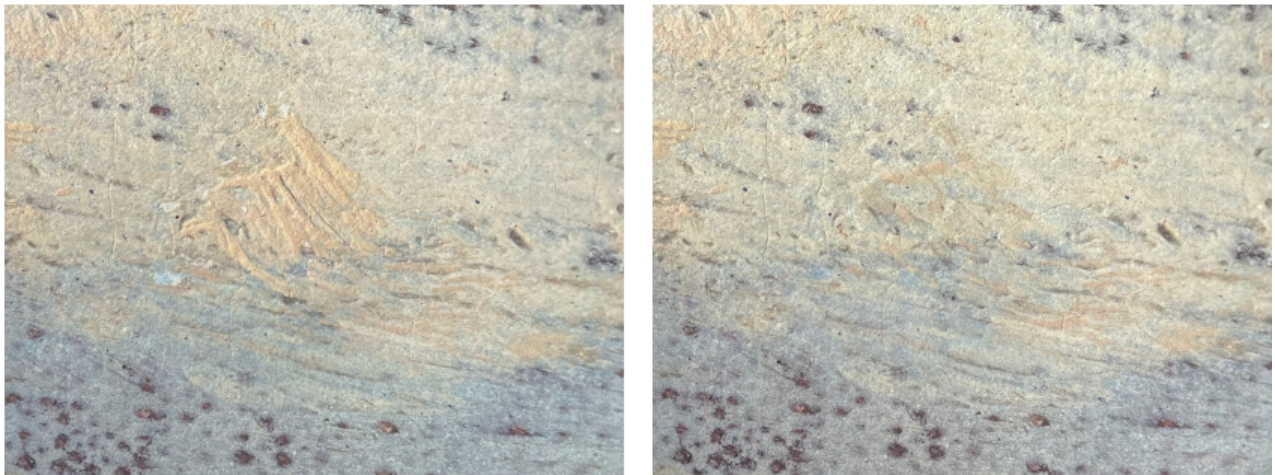
Detail of thick beige overpaint in cloud before (left) and after removal (right).

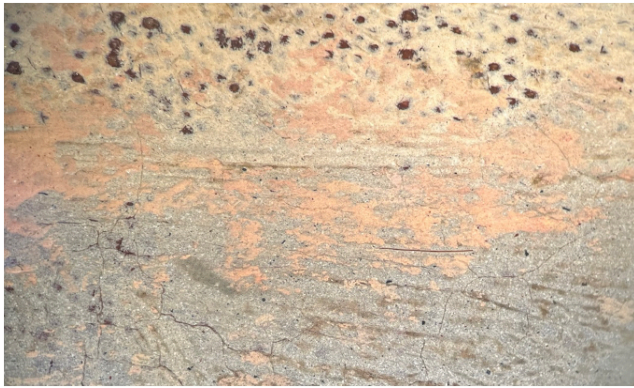
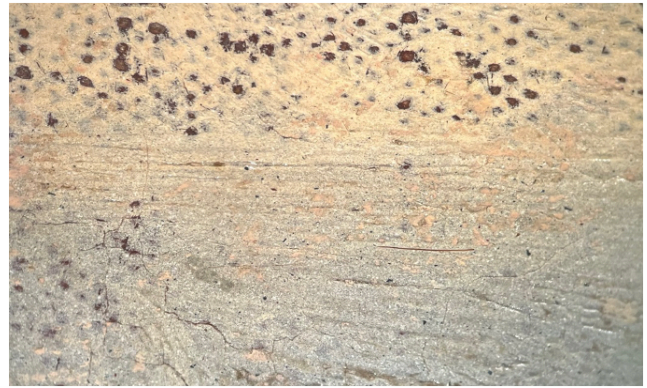
Detail of pink overpaint in cloud before (left) and after removal (right), using cleaning system with xanthan gum emulsion and mechanical action as illustrated above.

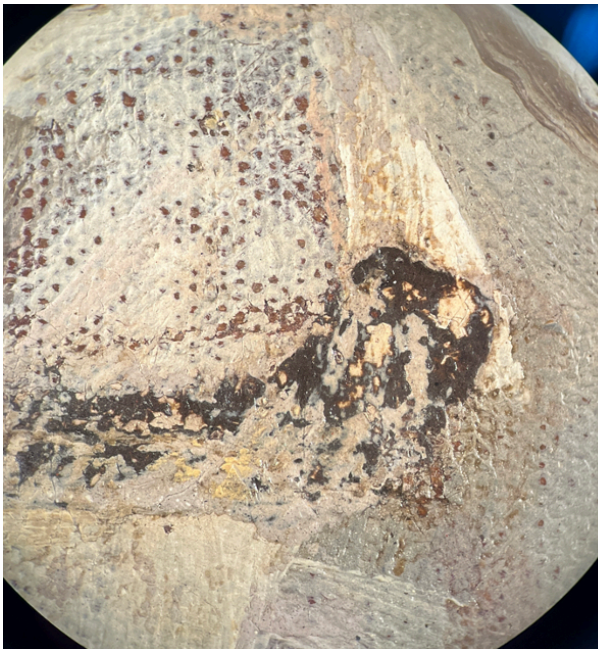
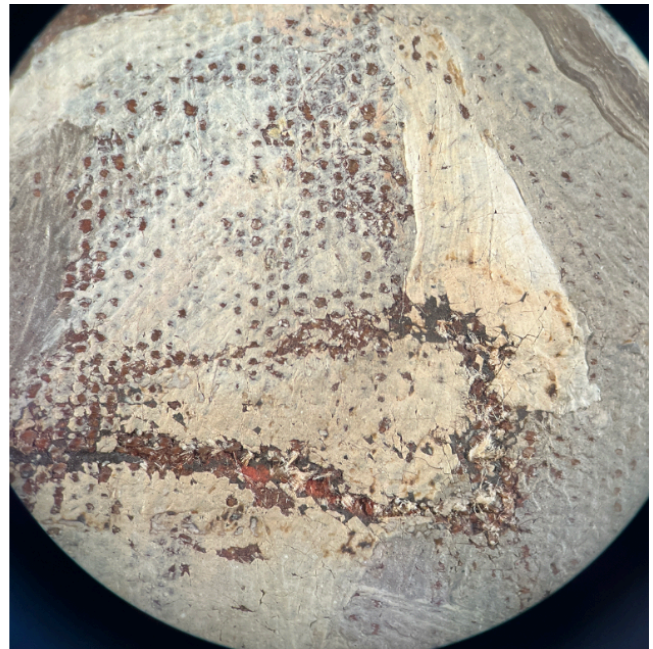
Micrographs of area before (left) and after removal (right) of overpaint and old fill, revealing original paint.
