## Examination and Treatment Report

29 December 2021

**Artist:** H. Bahgdasarian

**Title:** Mt Ararat

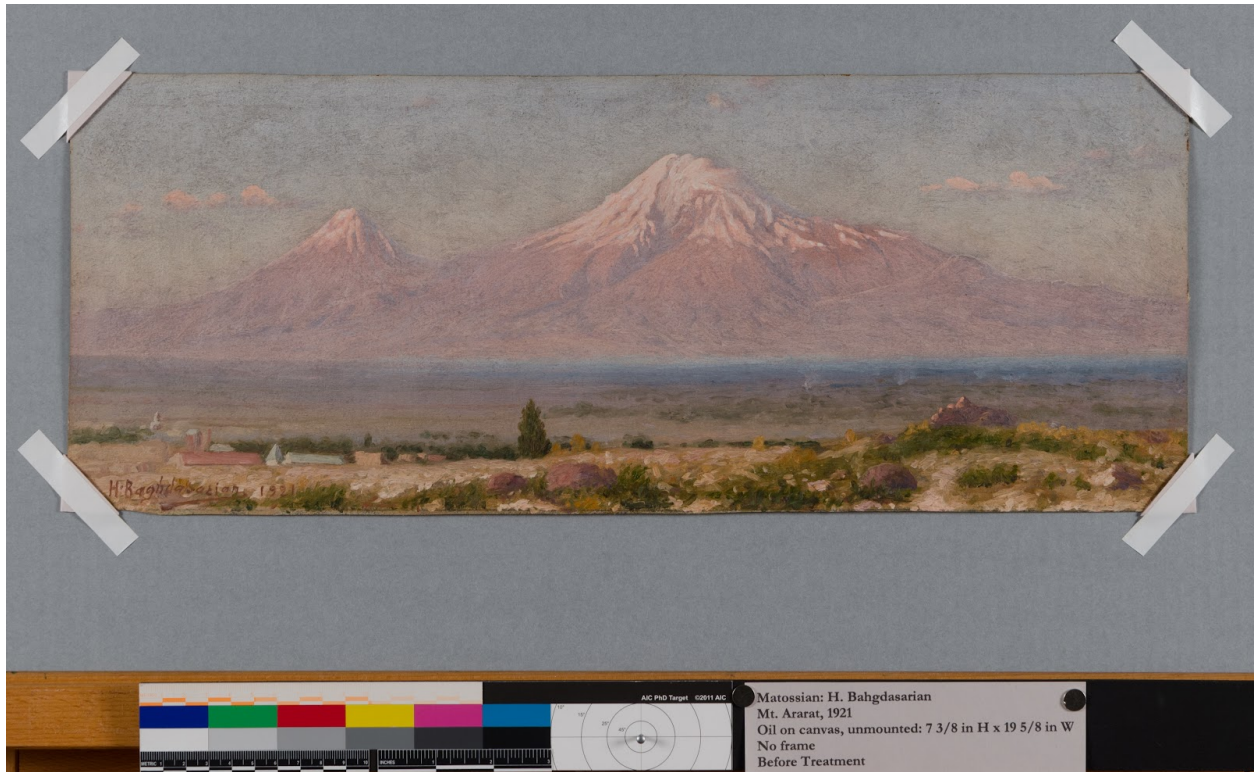
Front, Normal Illumination, Before Treatment.

The painting is in good condition overall. The paint and ground remain well-secured to the support and there is no significant surface grime or coating present.

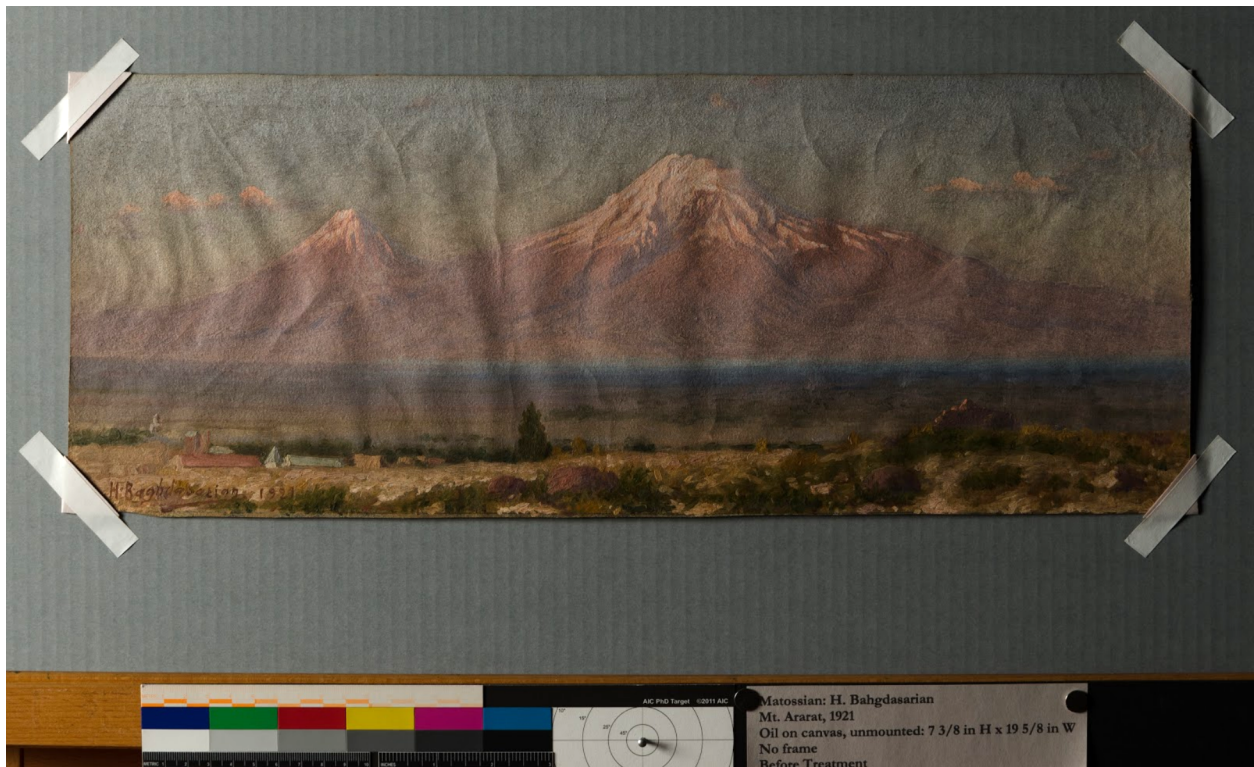
Front, Raking Illumination, Before Treatment.

In general, the canvas has an undulating planarity due to the development of mechanical cracks and distortions to the canvas. This occurred because it was unsupported in the frame, compressed between glass and backing board. There are localized mechanical cracks in the paint layer, primarily throughout the upper half and with one notable vertical crack running down to the left of the center of the painting. At the bottom edge of the left corner there is a cropping of the support  $\frac{1}{8}$  in H x  $1\text{-}\frac{5}{8}$  in W that relates directly to the cut edge of the glass that was in contact with the canvas.

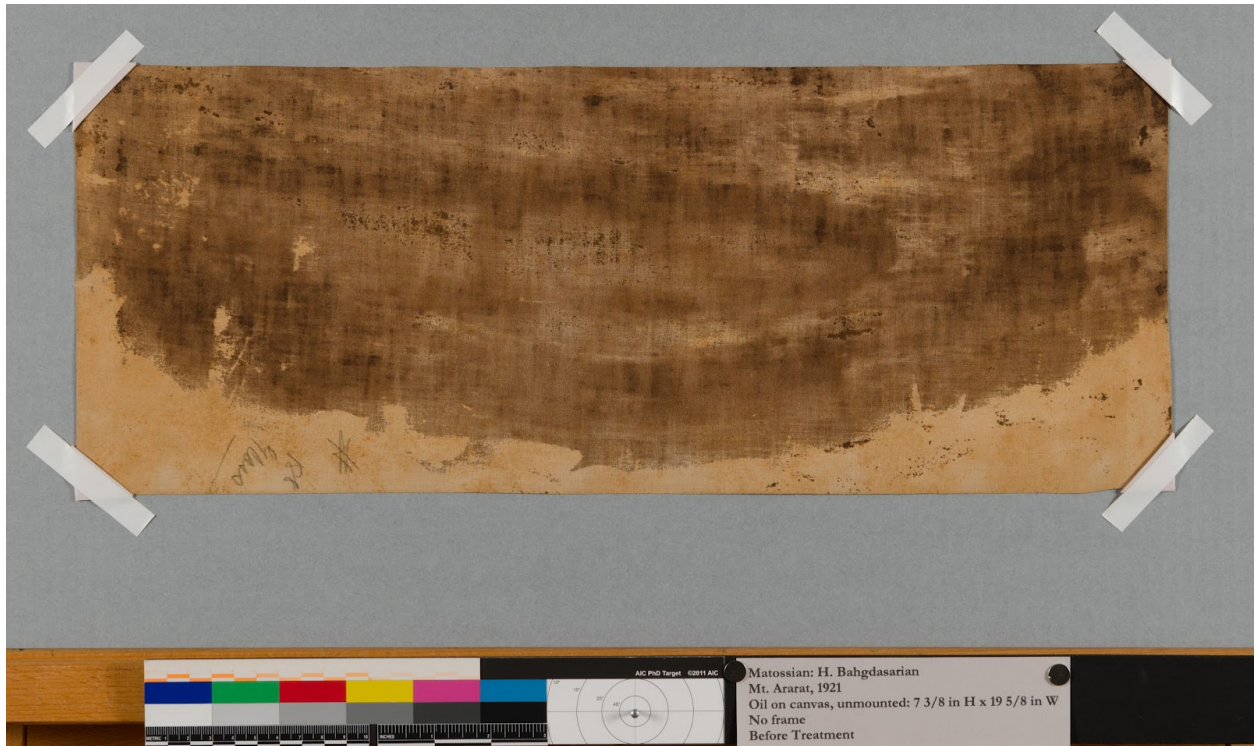
Back, Normal Illumination, Before Treatment.

The reverse of the canvas has variegated staining, discoloration, and darkening throughout due to the priming application, and possibly due to the paperboard backing.

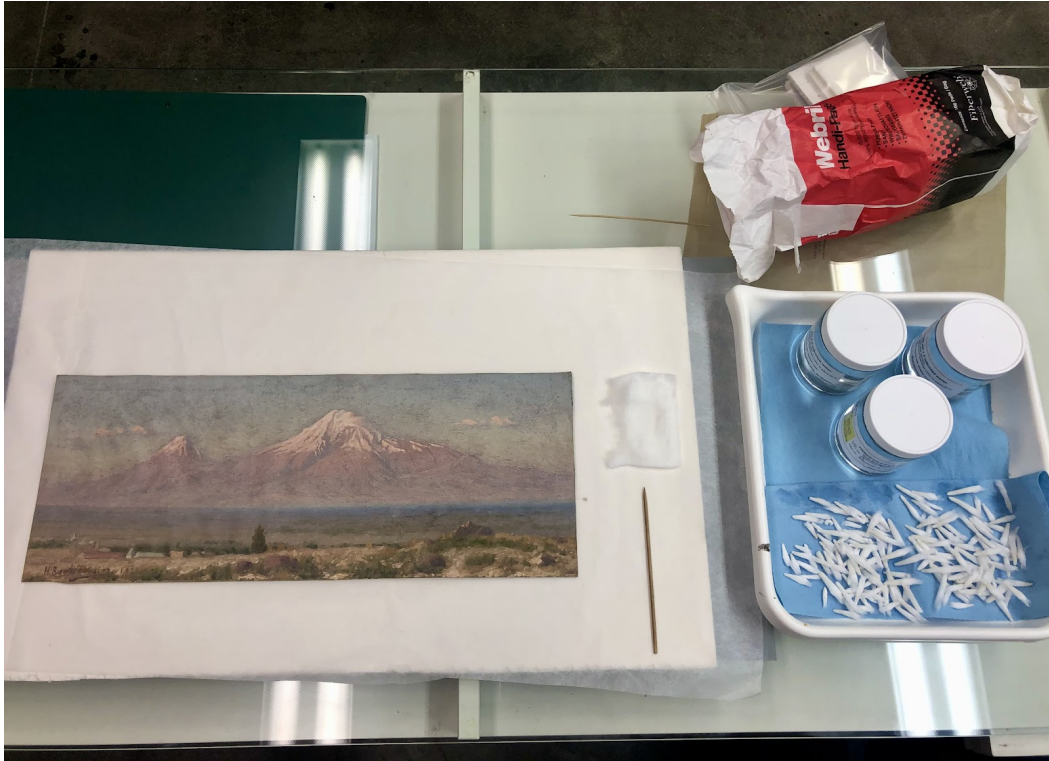
During Treatment. After grime removal using pH-adjusted aqueous solutions.

6. Tested small areas of the paint layer with all three pH-adjusted water solutions.
7. Cleaned and removed grime from face of painting using cotton swabs and pH-adjusted aqueous solutions at pH levels 5.5 and 6.5.

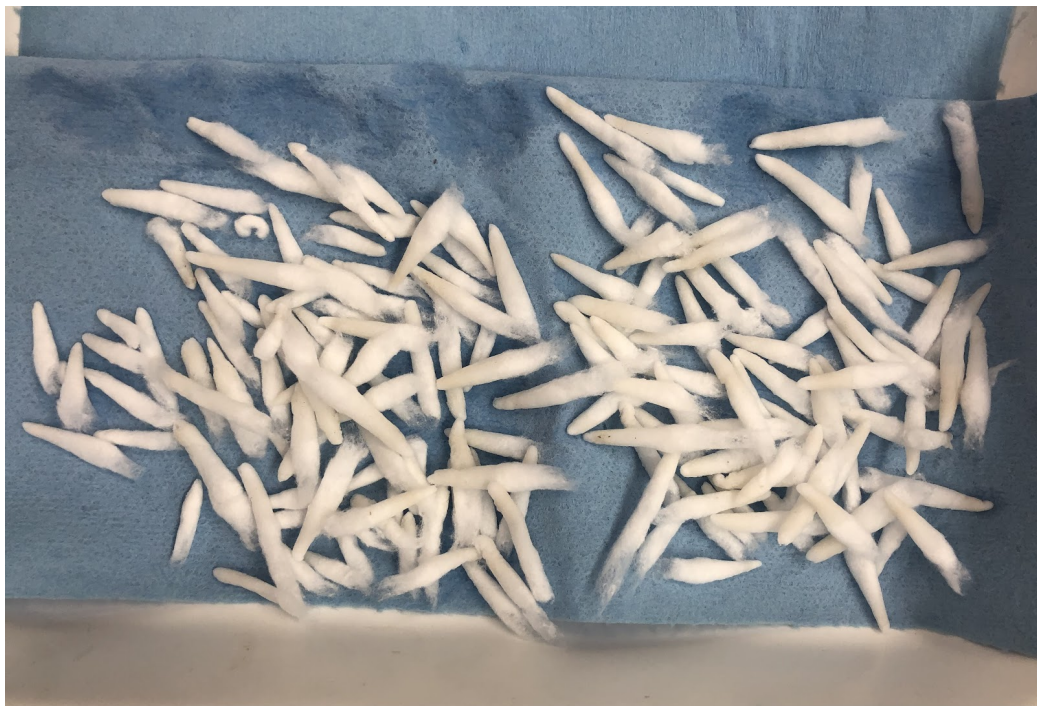
Used cotton swabs showing evidence of very subtle grime removal.

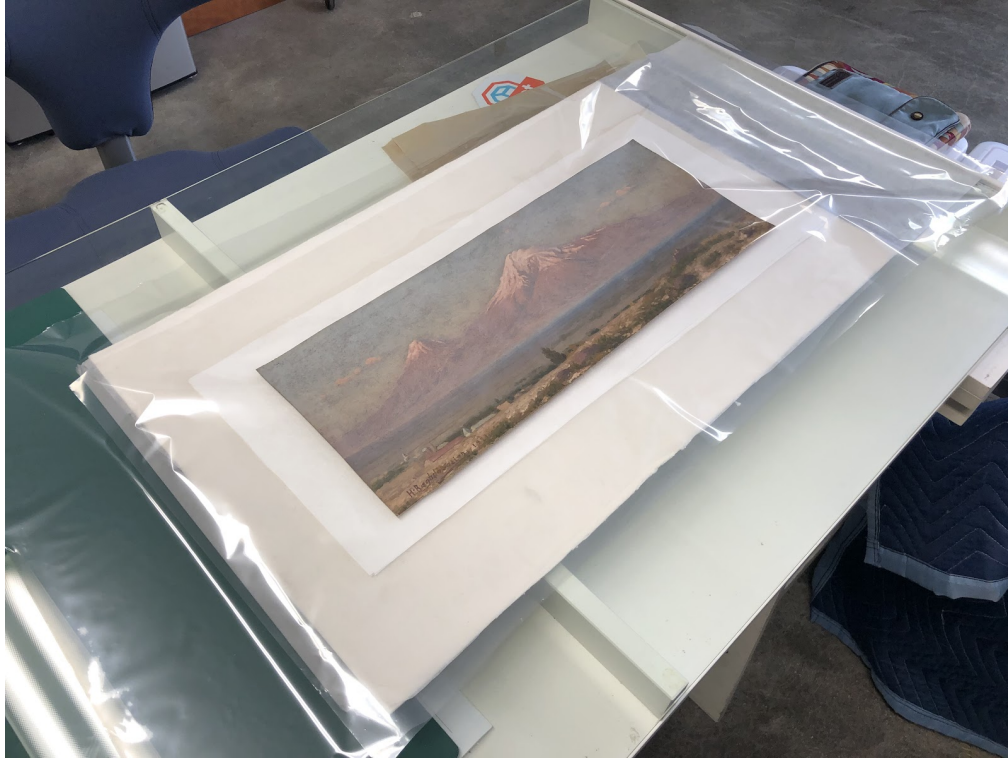
During Treatment. Humidification of painting.

9. Humidified painting by placing it between layers of Evolon CR, dry blotter, and one layer of damp blotter underneath the dry blotter, all of which were loosely encapsulated in mylar. The damp blotter was wetted with distilled water using a dahlia sprayer. Checked painting every 10 minutes and humidified for around 30 minutes.

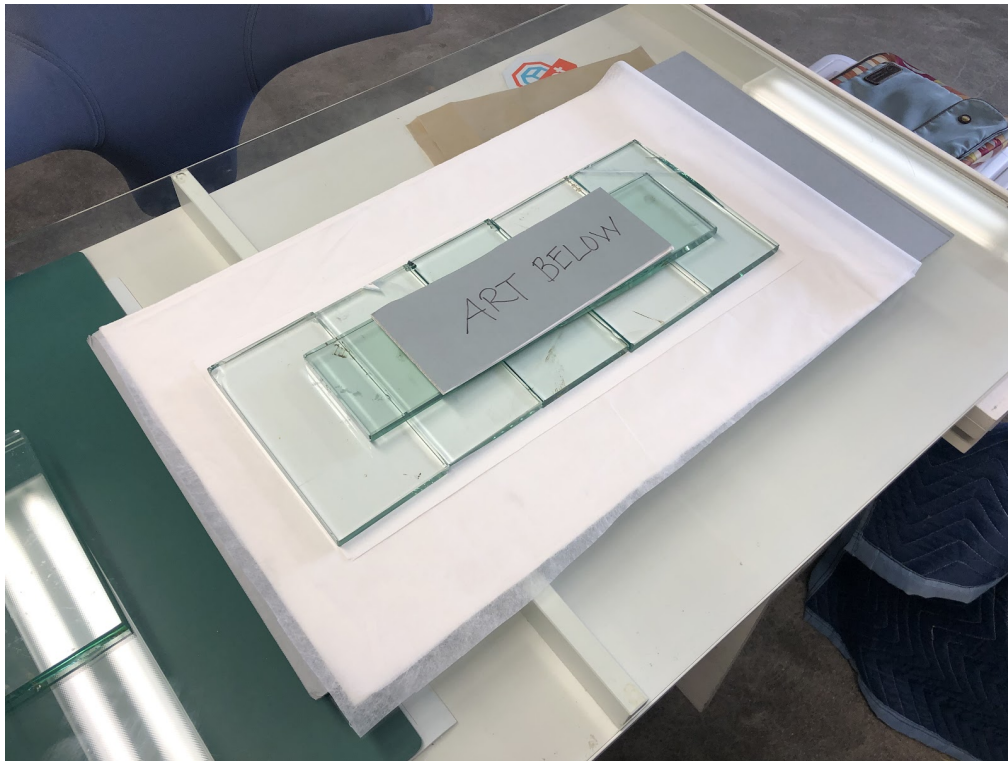
During Treatment. Flattening under weights after humidification.

10. Removed painting from humidification system. Placed painting between layers of Hollytex and blotter, and under weights in order to address planar deformations during drying. Left painting under weights overnight.
