CONSERVATION EXAMINATION REPORT

Title: Adoration of the Golden Calf

Conservator: Josephine Ren (graduate intern)

CONSERVATION TREATMENT REPORT

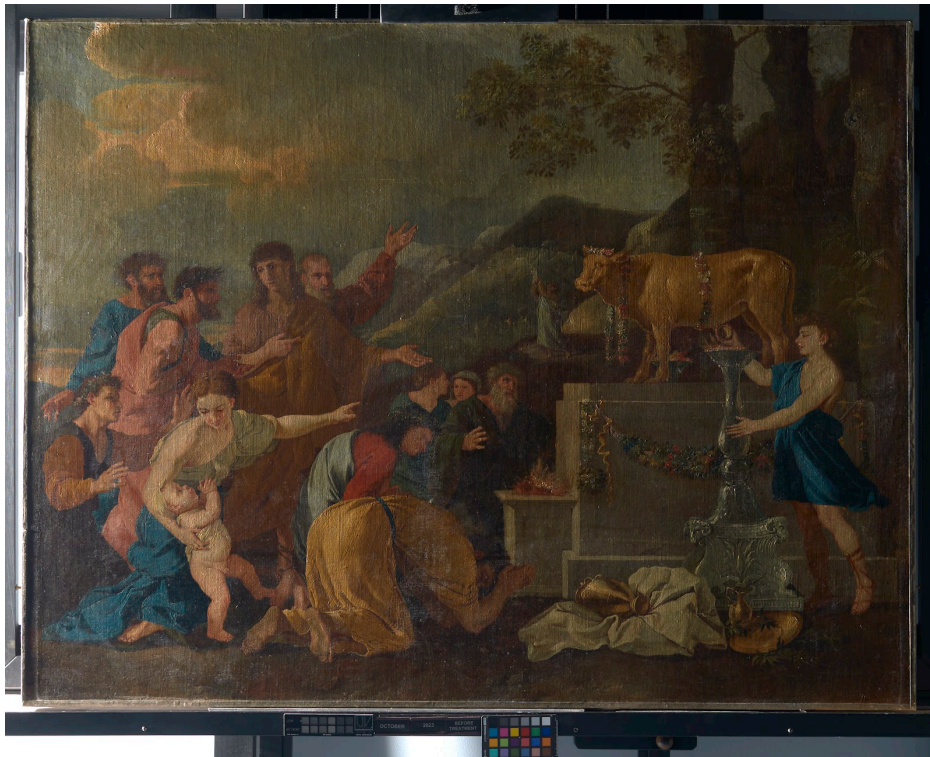
A few small losses are in the top edge by the left and right corners. An extremely fine craquelure is present throughout the overall paint surface. A long, fine crack is present along the location of the restored horizontal tear in the upper third section of the painting. Several scratches were documented in 2013 while the painting was on display in the Legion of Honor, and appear to partially run through the paint layer. Four vertical scratches are in the lower center around the arm of the kneeling figure in red, right above the kneeling figure in yellow. Three vertical scratches are in the legs and surrounding areas of the standing youth on the right.

Before treatment, front, raking illumination.

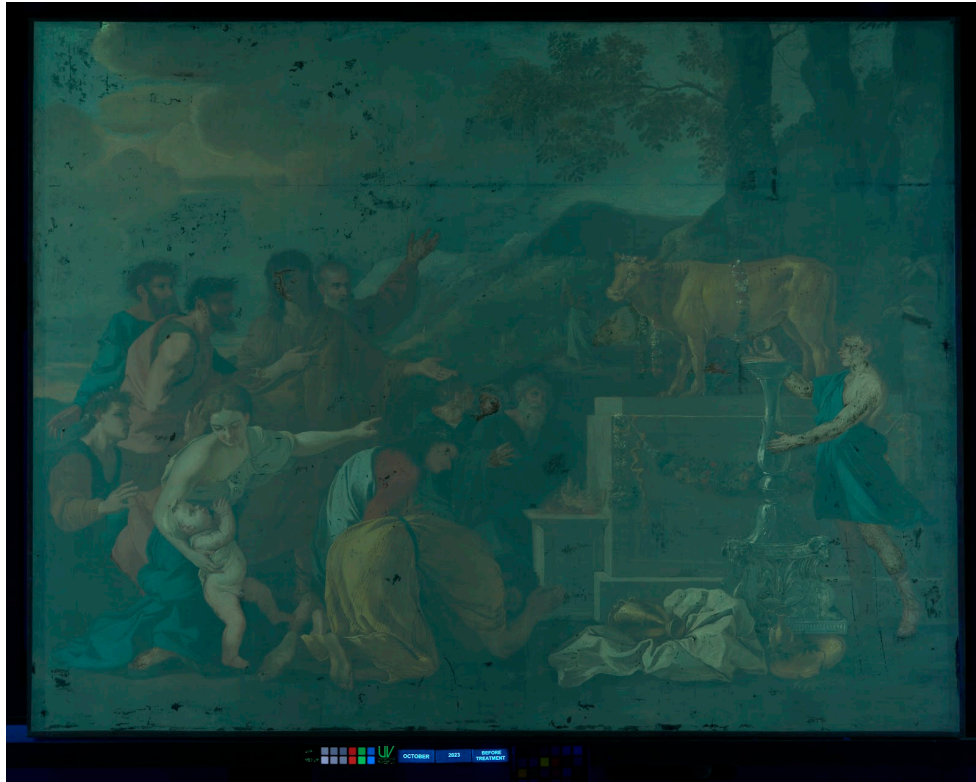
The paint surface is highly abraded in the sky, the calf, and a few figures (notably the young boy on the right, the mother and her baby). There are widespread pinhole losses and pinpoint abrasion throughout these abraded areas, revealing the ground underneath and even the canvas in some areas. Abrasion has resulted in loss of some painted details, such as in the flower crown of the leftmost figure. The paint surface throughout the sky exhibits the most abrasion and damage. The paint has also become transparent over time in some areas. The texture of aesthetic restoration along the tear repair is visible when viewed in raking and specular light, and its accompanying crack has some discolored retouching. Large amounts of disfiguring overpaint are present throughout, such as in the sky and in some of the figures and faces. There are numerous areas of discolored retouching throughout the composition; the retouching medium has also developed a white, hazy appearance in many areas.

Before treatment, front, UVA-induced visible fluorescence.

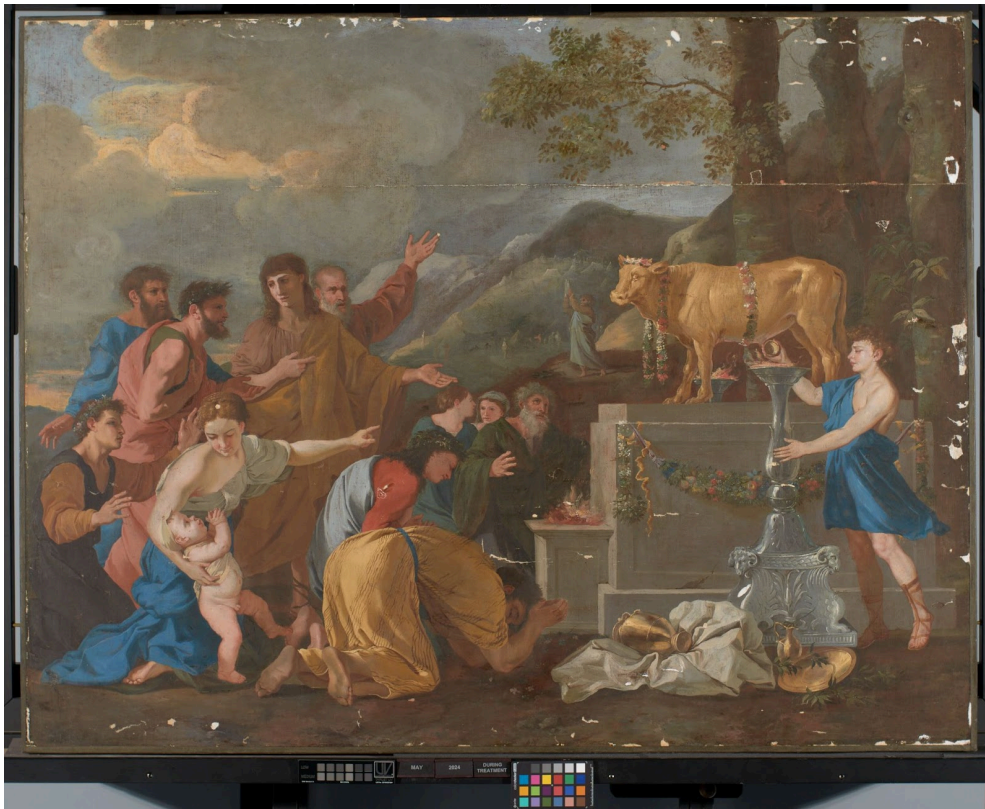
During treatment, after cleaning, front, normal illumination.

3. Conducted aqueous solubility tests for surface-cleaning with saliva and deionized water.
4. Removed surface dirt with saliva and cotton swabs.
5. Conducted solvent solubility tests to determine a system for varnish removal.

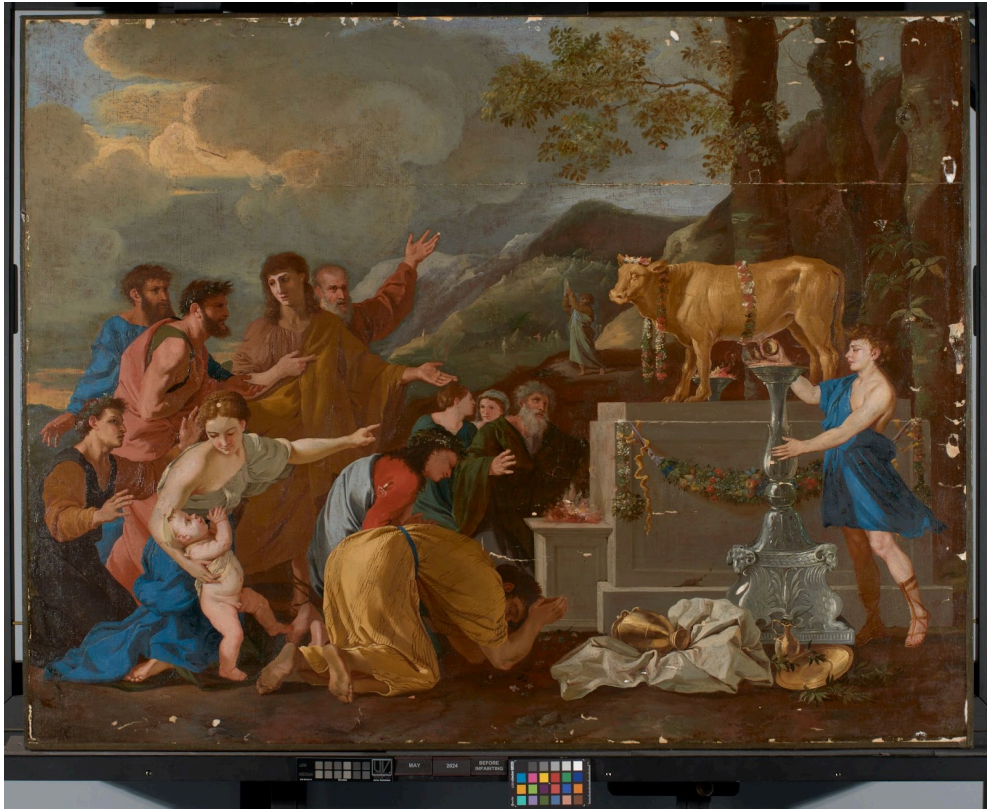
During treatment, after varnishing and before inpainting, front, normal illumination.

12. Varnished painting by brush with ~20% Laropal A81 in 1:1 Shellsol D38:Shellsol A100 plus ~2% Tinuvin 292 to re-saturate and level out paint surface.

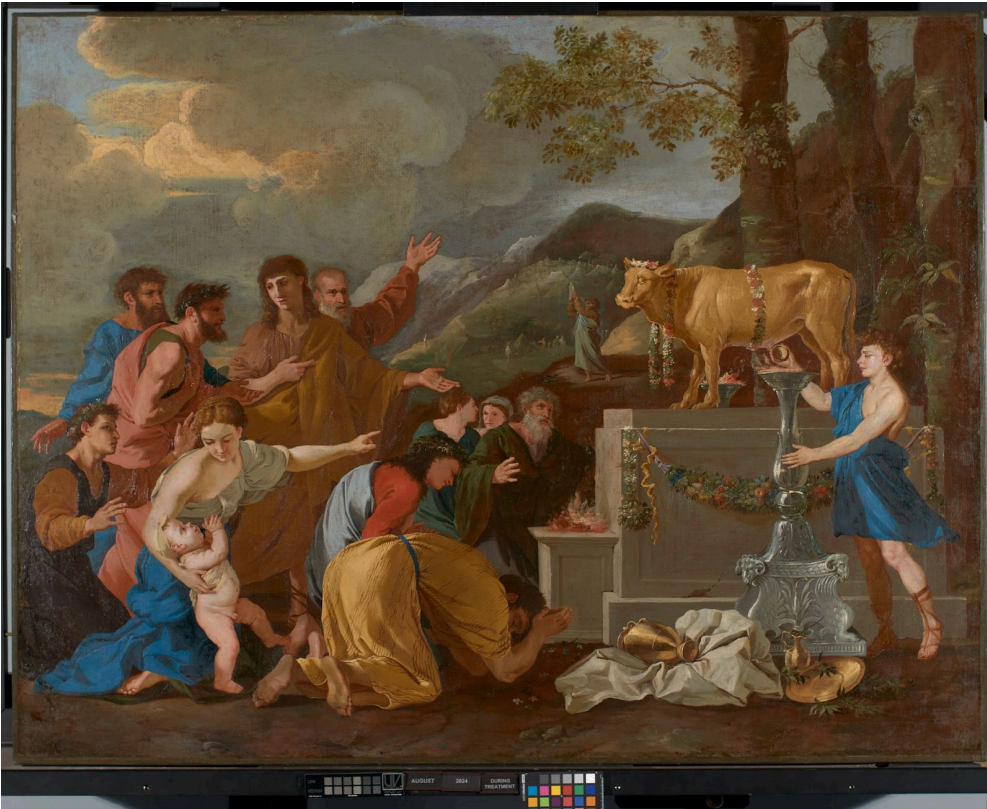
During treatment, during inpainting, front, normal illumination.

Losses were filled and pre-existing fills were textured using Flugger. The majority of pre-existing fills were left as is since they were stable, well-executed, and did not cover any original material. The painting was varnished by brush with 20% Laropal A81 in 1:1 Shellsol D38:Shellsol A100 plus 2% Tinuvin 292. Laropal A81 was chosen for its similar appearance to natural resin, its moderate gloss level, even saturation, and ease of application. Losses, abrasion, and discolored overpaint were inpainted using Gamblin Conservation colors and diluents of isopropanol and 1-methoxy-2-propanol. Using a diluent of 1-methoxy-2-propanol was especially useful for inpainting areas with extensive pinhole abrasion.

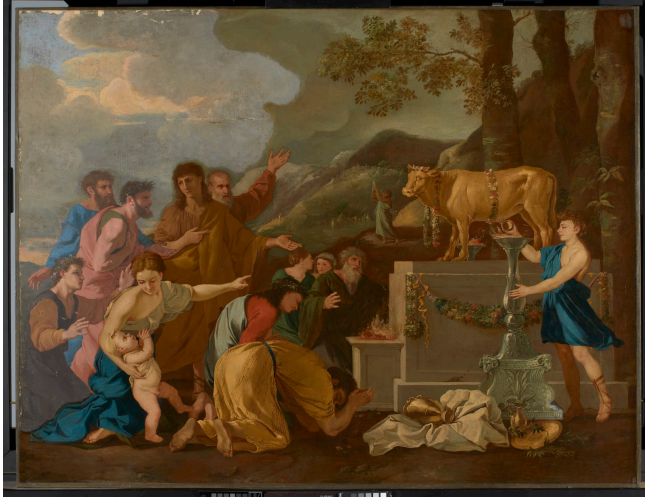
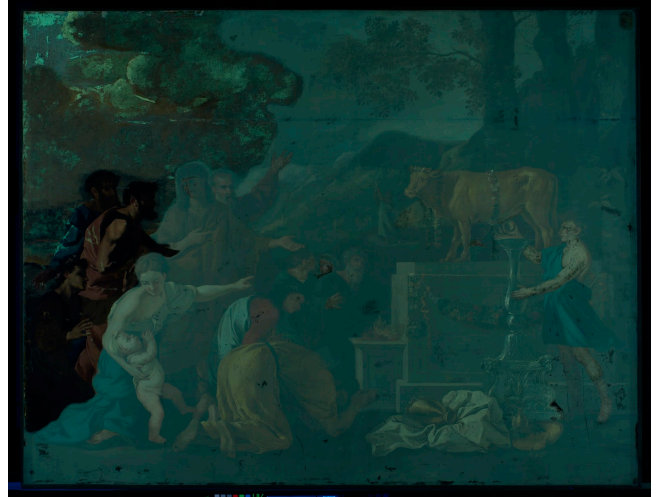
During treatment, progression of varnish removal, normal light (left) and UV (right).

6. Removed varnish with 2:1 toluene:ethanol and cotton swabs. Typically two passes of this solvent mixture were required to remove the majority of the varnish. Remaining residues of varnish were removed with one broad pass of 2:1 ethanol:iso-octane.

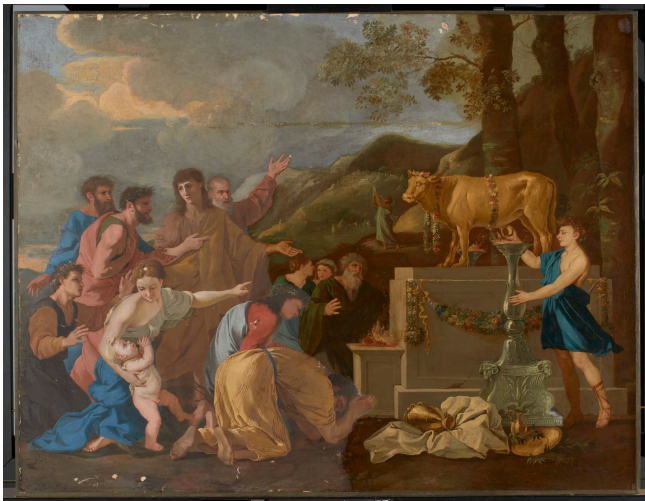
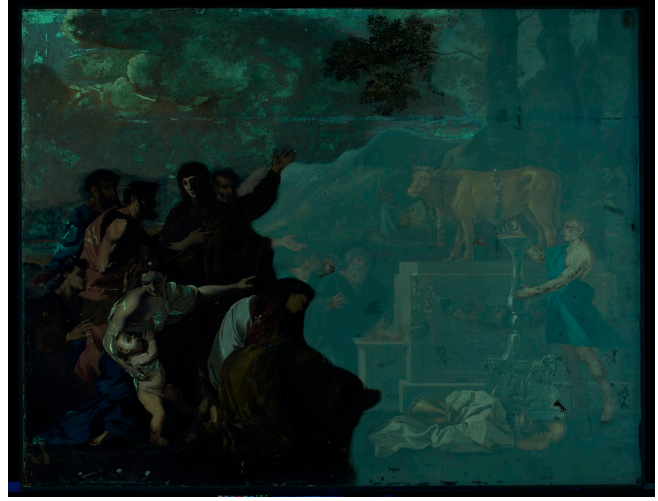
During treatment, halfway progression of varnish removal, normal light (left) and UV (right).

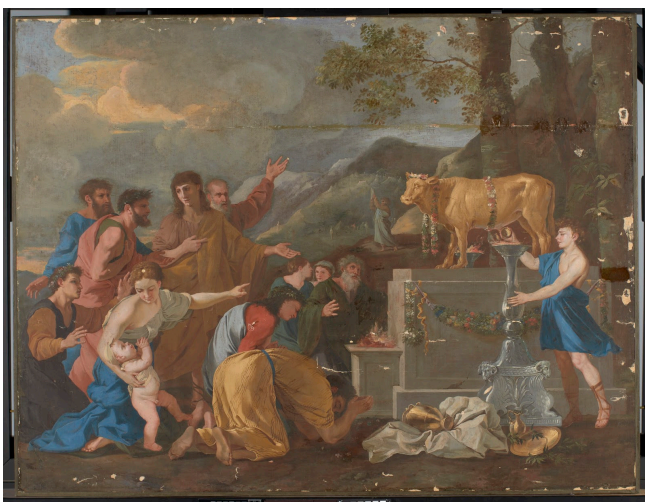
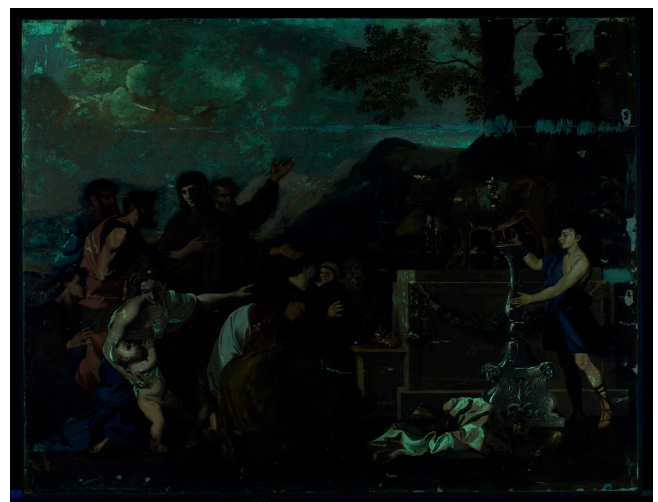
During treatment, after varnish removal, normal light (left) and UV (right).

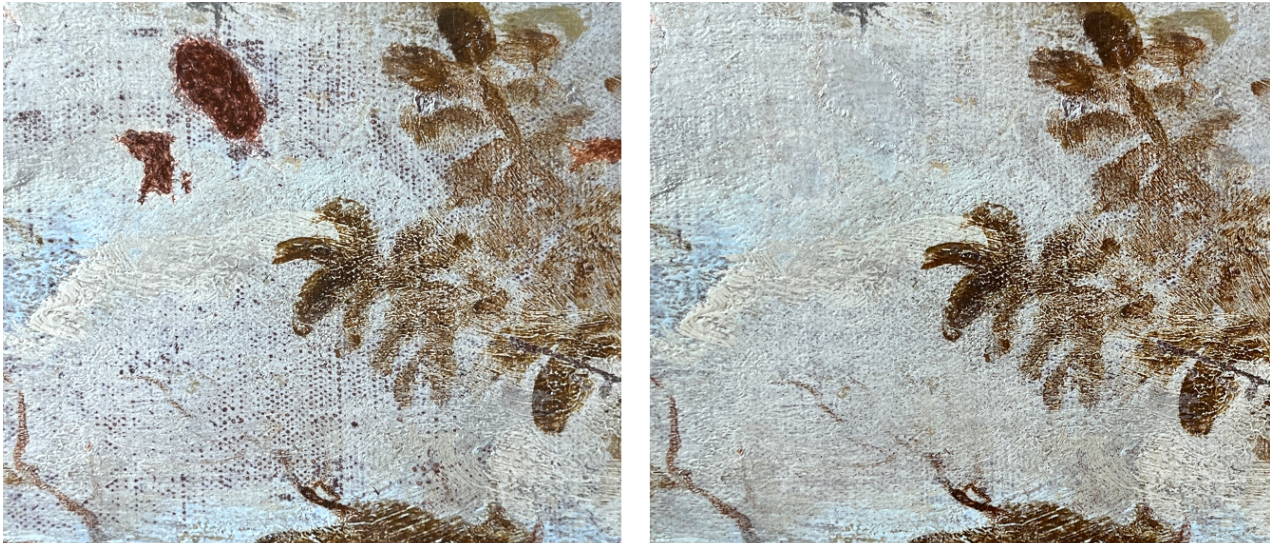
Details of area in background during successive stages of inpainting.

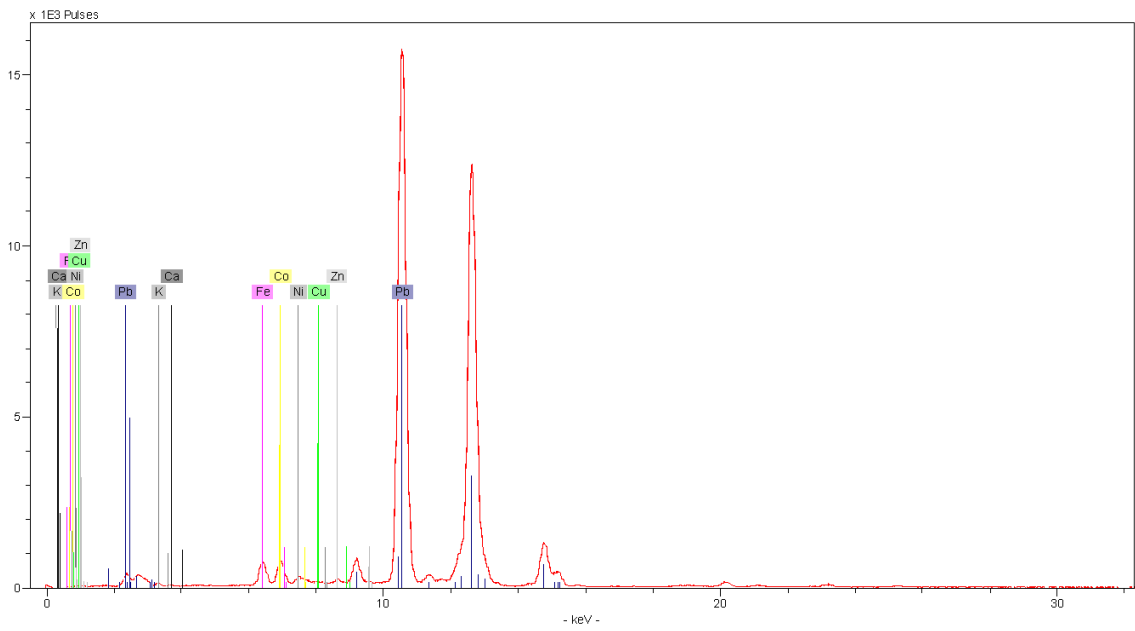
Spot 21, light blue

Notable peaks: Zn, Pb, Fe

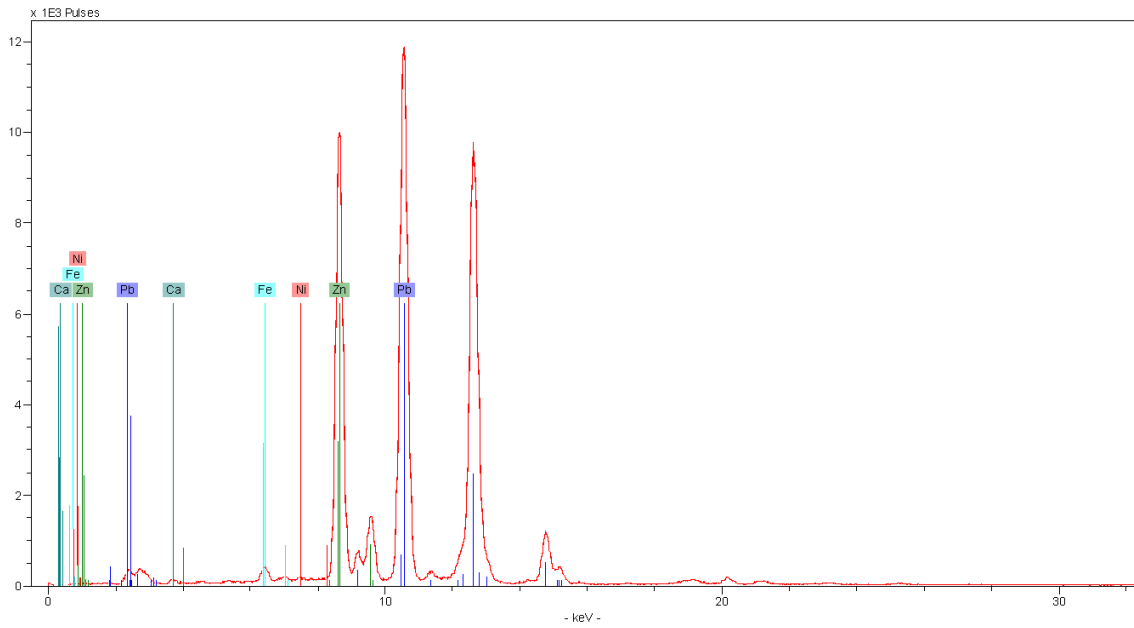
Spot 22, warm white

Notable peaks: Zn, Pb, Hg, Sn, Fe
